ENVIRONMENTAL MONITORING & COMPLIANCE AUDIT REPORT

PROPOSED REPLANTING AND PLANTING OF 25,000 HA
OF ACACIA MANGIUM AT BENGKOKA PENINSULA,
DISTRICT OF PITAS, SABAH BY ACACIA FOREST
INDUSTRUES SDN BHD.

1ST REPORT OF YEAR 2020

Date of Report : 20th April 2020

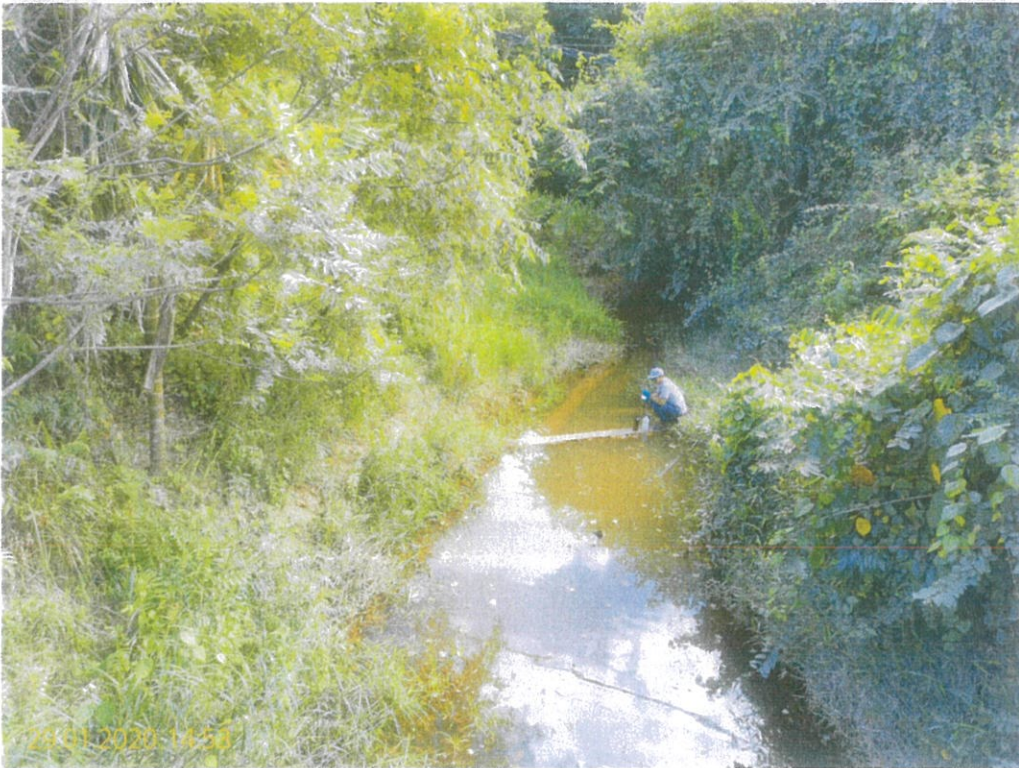
Plate 1

Water sampling exercises were conducted at monitoring location, **W1**.

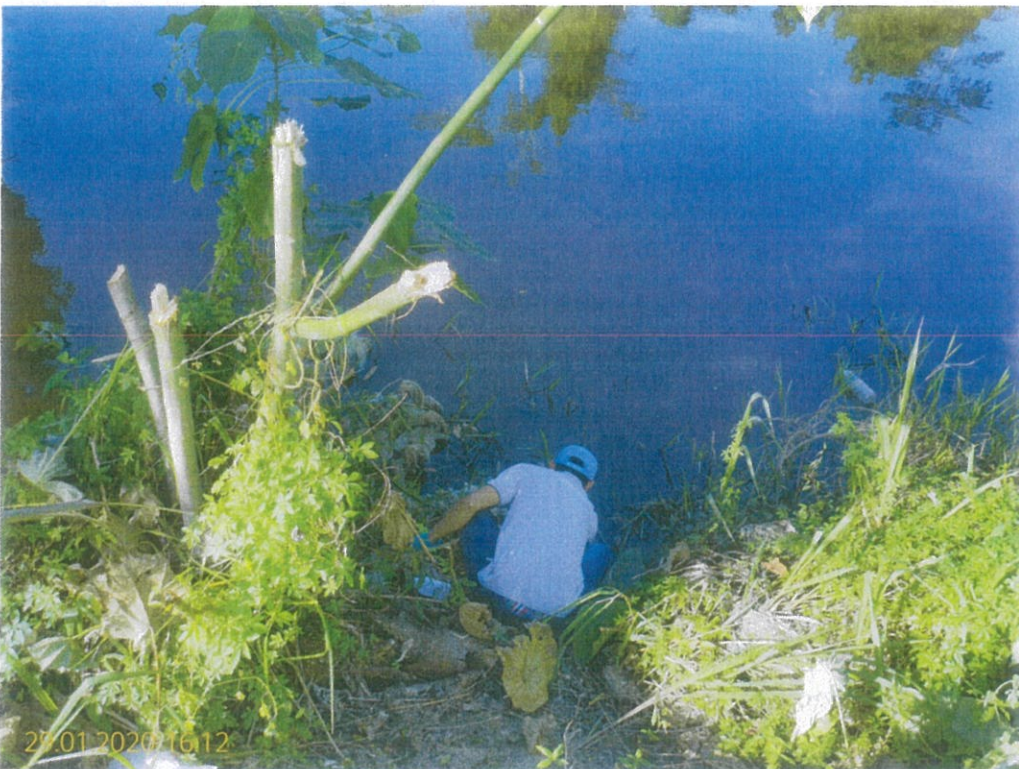
Plate 2

Water sampling exercises were conducted at monitoring station **W3**.

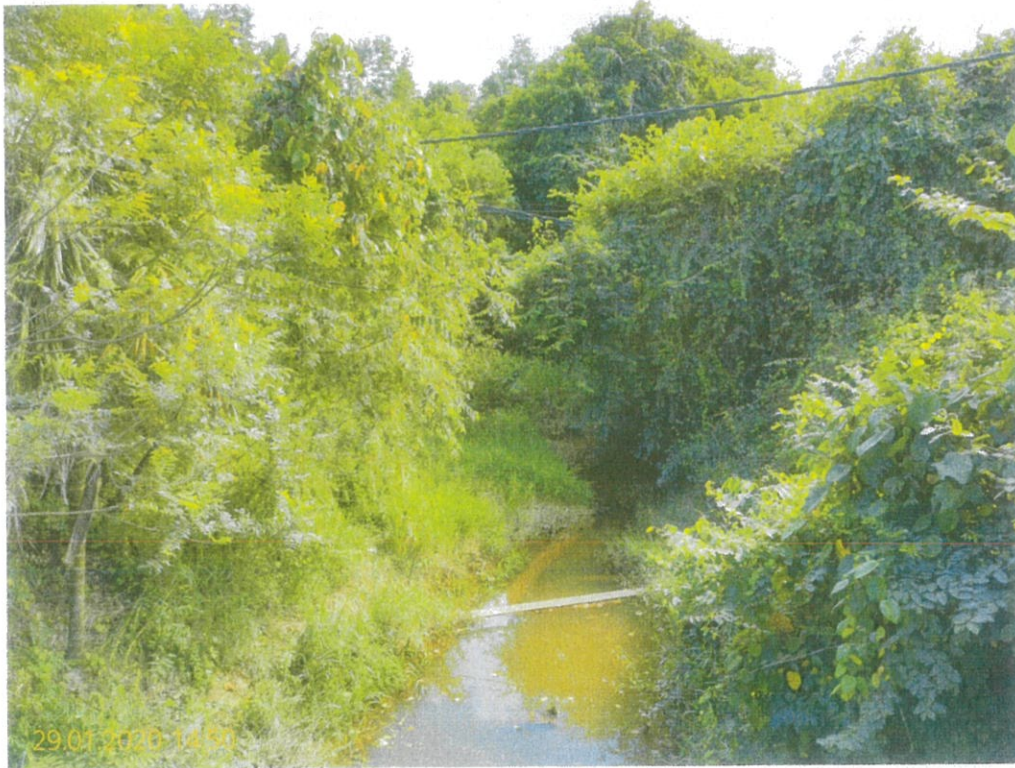
Plate 5

v	Sebarang aktiviti pemajuan ladang Acacia mangium dan penumbangan kayu <u>tidak dibenarkan</u> di simpanan sungai ini.	Comply	<ul style="list-style-type: none"> There were no signs of any activities carried out within the Riparian Reserves area as observed during the site visit. There are no signs of any structure constructed within the Riparian Reserves area, except 	Plates 5 & 6	-

AEC No.	Approved Environmental Conditions	Status	Observations / Comments	Photo No.	Corrective Action and Completion Date
vi	Sebarang pembinaan rumah pekerja, kem pekerja, bengkel, tandas atau struktur bangunan lain tidak dibenarkan di simpanan sungai ini.	Comply	<p>for the previous water pump house, which had been dismantled.</p> <ul style="list-style-type: none"> Refer to the comments in AEC 5.3 (v). 	Plates 5 & 6	-
vii	Sebarang penyimpanan bahan minyak atau bahan toksik tidak dibenarkan di simpanan sungai ini.	Comply	<ul style="list-style-type: none"> There were no signs of any oily / toxic material being stored within the Riparian Reserves as observed during the site visit. The oily / toxic material storage area was situated near the workshop area and located at more than 50 m away from any nearest natural waterways. 	Plates 5 & 6	
viii	Sebarang bahan tanah lebihan, sisa tumbuhan, sisa pepejal, kumbahan, bahan minyak, kimia atau bahan-bahan toksik tidak dibenarkan dilupuskan di simpanan sungai, di dalam sungai atau alur air.		<ul style="list-style-type: none"> There is no disposal of any overburden or any types of wastes (i.e. biomass, solid wastes, sewage, oily / toxic material, etc.) into the Riparian Reserves area or any nearest natural waterways as observed during the site visit. 	Plates 5 & 6

View towards the tributary of Sg. Malubang.

No markers were noted to demarcate the riparian reserves as observed during the site visit.

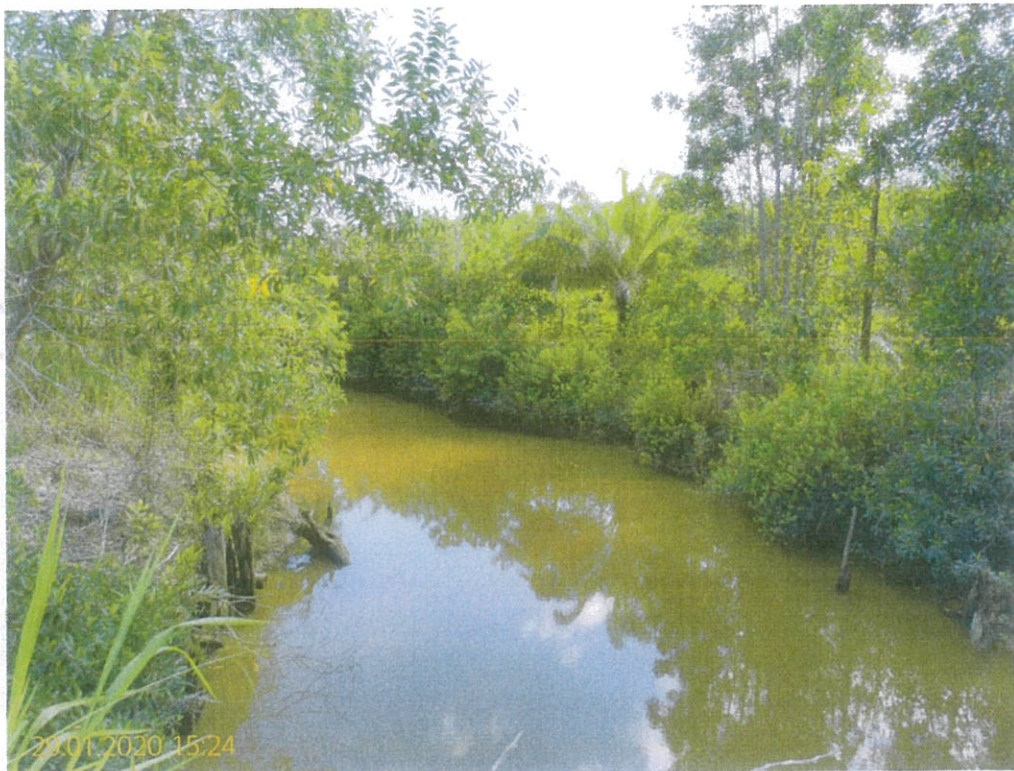
Plate 6

View towards Sg. Kakarangan.

No markers were noted to demarcate the riparian reserves as observed during the site visit.

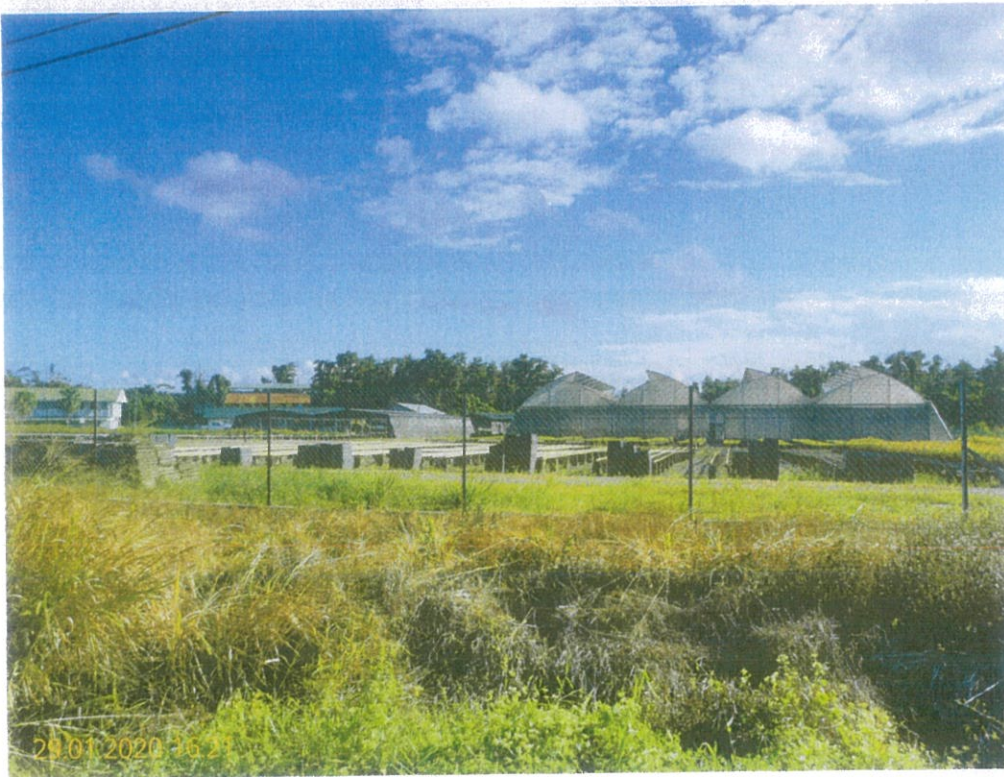
Plate 9

View towards the nursery located within the Project site.

The facility was located at more than 50 m away from any nearest natural waterways.

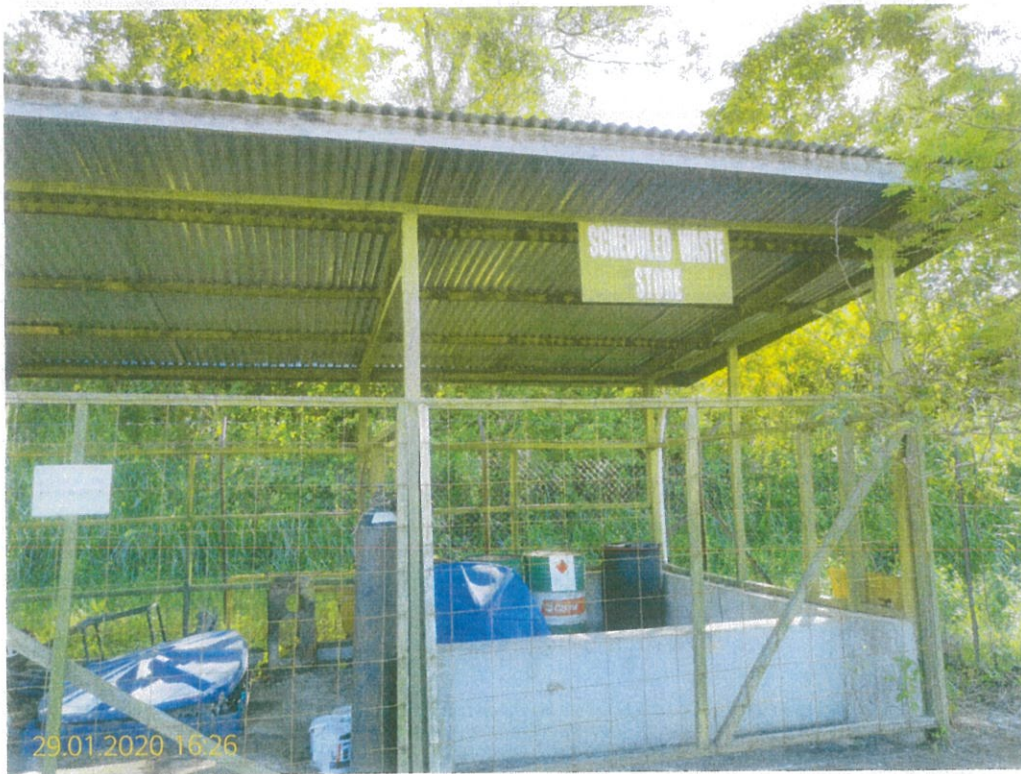
**Plate 13**

5.7	<u>Bahan Minyak dan Sisa Toksik</u>				
i	Bahan minyak dan sisa toksik yang digunakan dalam aktiviti pemajuan ladang Acacia mangium ini adalah <u>tidak dibenarkan</u> dilupuskan atau dibiarkan mengalir ke dalam parit, sungai atau alur air.	Comply	<ul style="list-style-type: none"> There is no disposal of any oily and toxic material into the nearest natural waterways as observed during the site visit. 	-	-
ii	Bahan minyak dan sisa toksik hendaklah dikumpul dan disimpan dalam bekas yang kukuh dan tidak mudah bocor. Bekas-bekas penyimpanan tersebut hendaklah dilabel.	Comply	<ul style="list-style-type: none"> Oily materials and spent oils were stored inside HDPE and metal drum containers, and labelled accordingly. The oil and scheduled waste on-site were stored at the storage facility located near the existing workshop. According to the Project Proponent, the disposal of scheduled wastes was handled by Petrojadi Sdn. Bhd. 	Plates 13 to 15	-

View towards the scheduled waste storage area, which was situated at the workshop nearby the site office.

The facility were equipped with concretized floor and perimeter concrete containment bund.

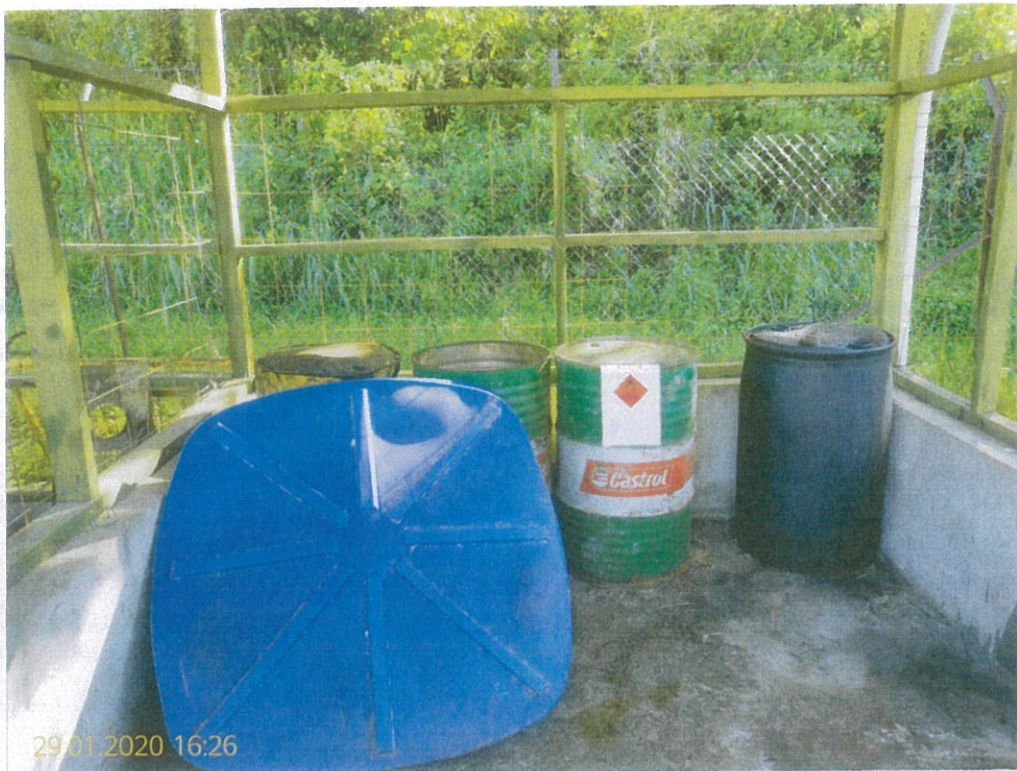
**Plate 14**

The schedule wastes were stored and labelled accordingly.

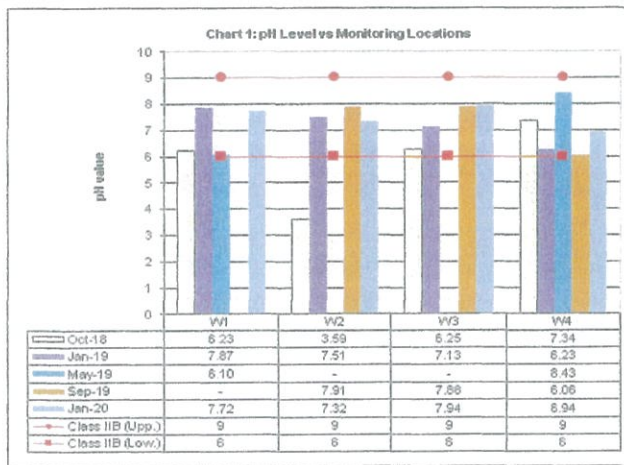
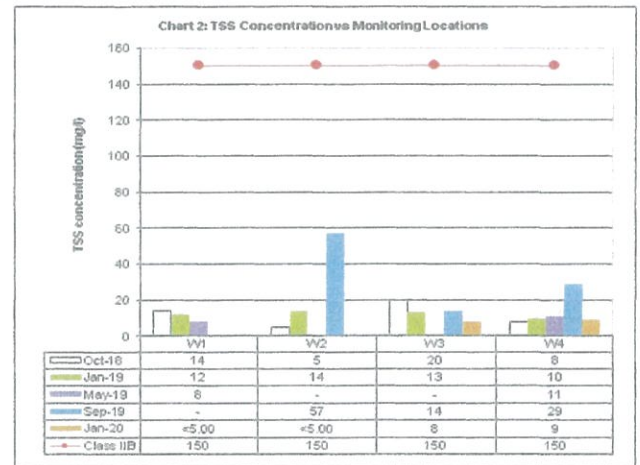
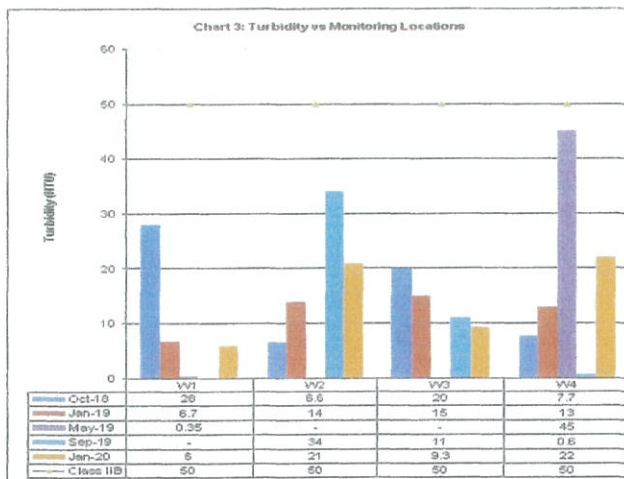
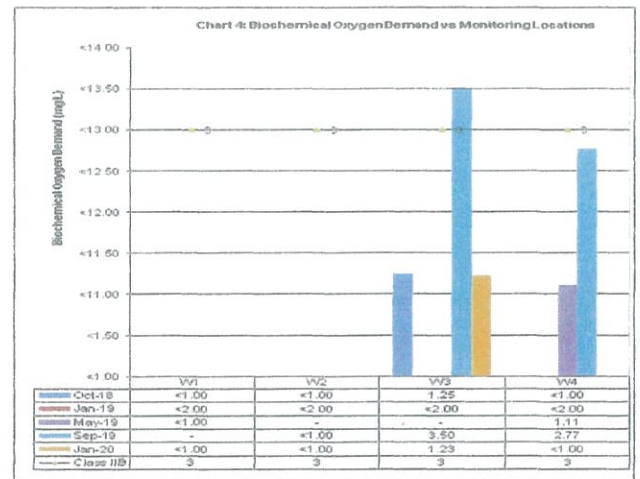
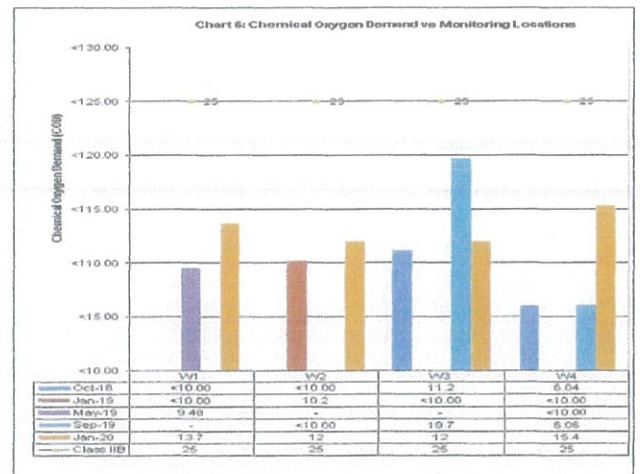
HISTORICAL WATER QUALITY RESULTS (W1 – W4)

Surface water quality results are tabulated in **Table 2.0** and compared against **Class IIB** of **National Water Quality Standards for Malaysia (NWQSM)**. The test reports are presented in **Appendix C**. **Charts 1.0 – 7.0** present the historical surface water quality results for monitoring locations, **W1 – W4**.
