## ENVIRONMENTAL COMPLIANCE AUDIT REPORT

PROPOSED REPLANTING AND PLANTING OF 25,000 HA  
OF ACACIA MANGIUM AT BENGKOKA PENINSULA,  
DISTRICT OF PITAS, SABAH BY ACACIA FOREST  
INDUSTRIES SDN BHD.

3<sup>RD</sup> REPORT OF YEAR 2018

AEC Ref. No. : JPAS/PP/15/600-1/01/3/29  
Report Reference : CK/MO411/1188-3/18  
Date of Report : 4<sup>th</sup> December 2018

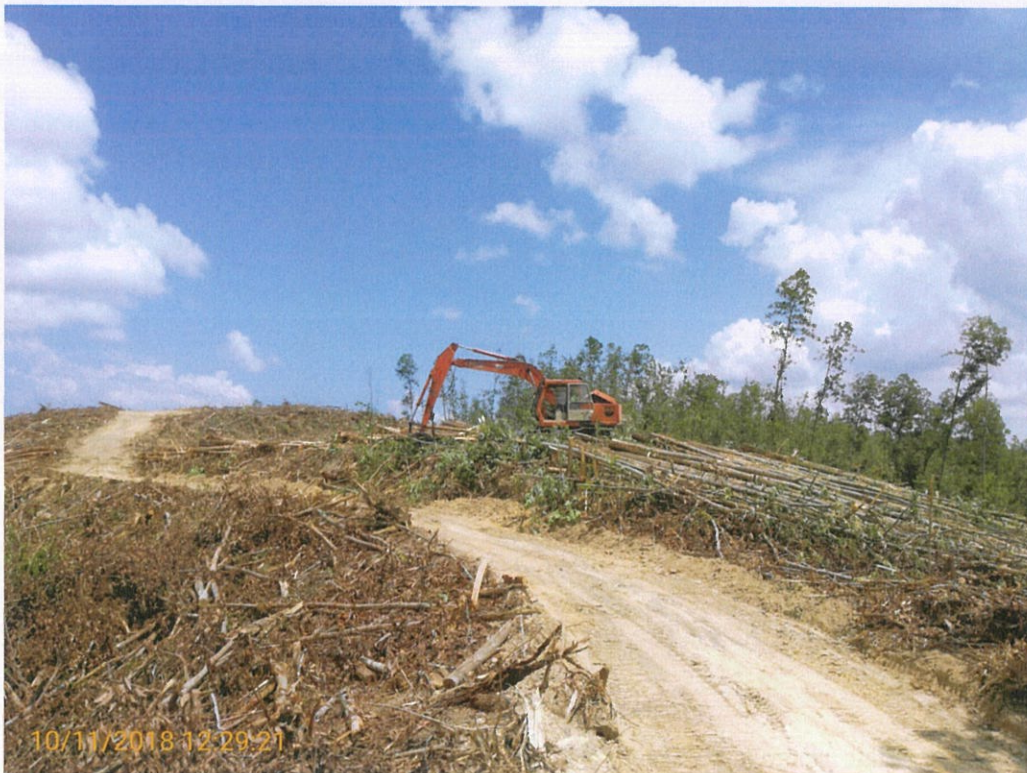
**Plate 1**

The logging activities on-site were confined within the Project site only.

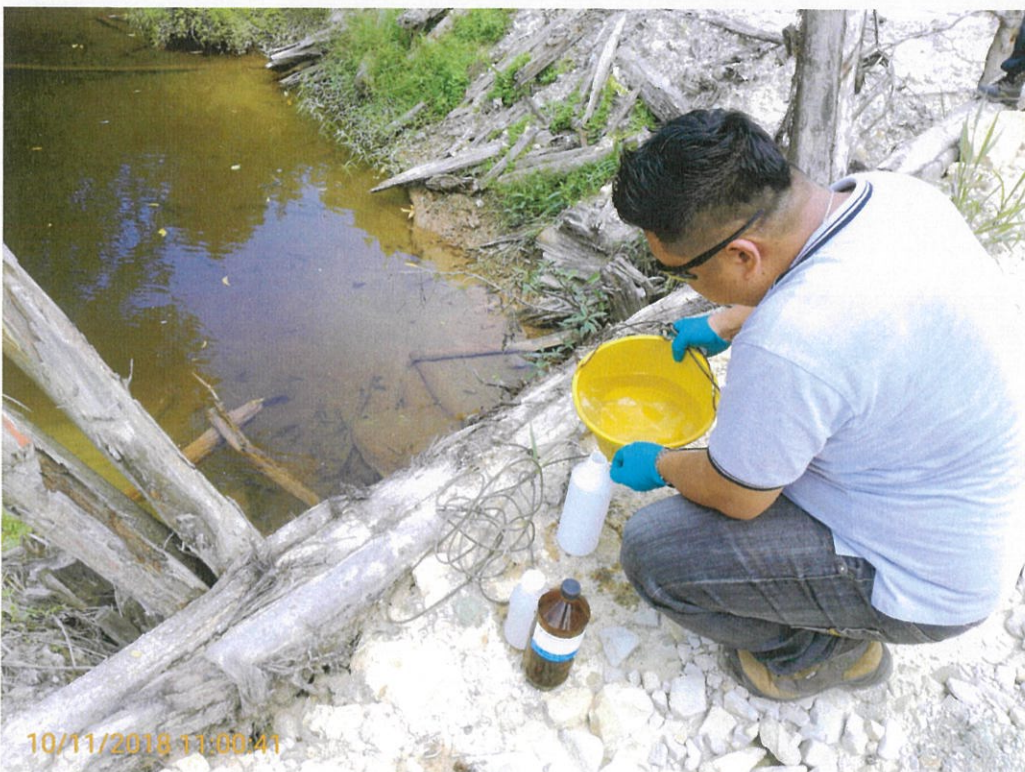
**Plate 2**

Water sampling exercises were conducted at monitoring station **W2**.

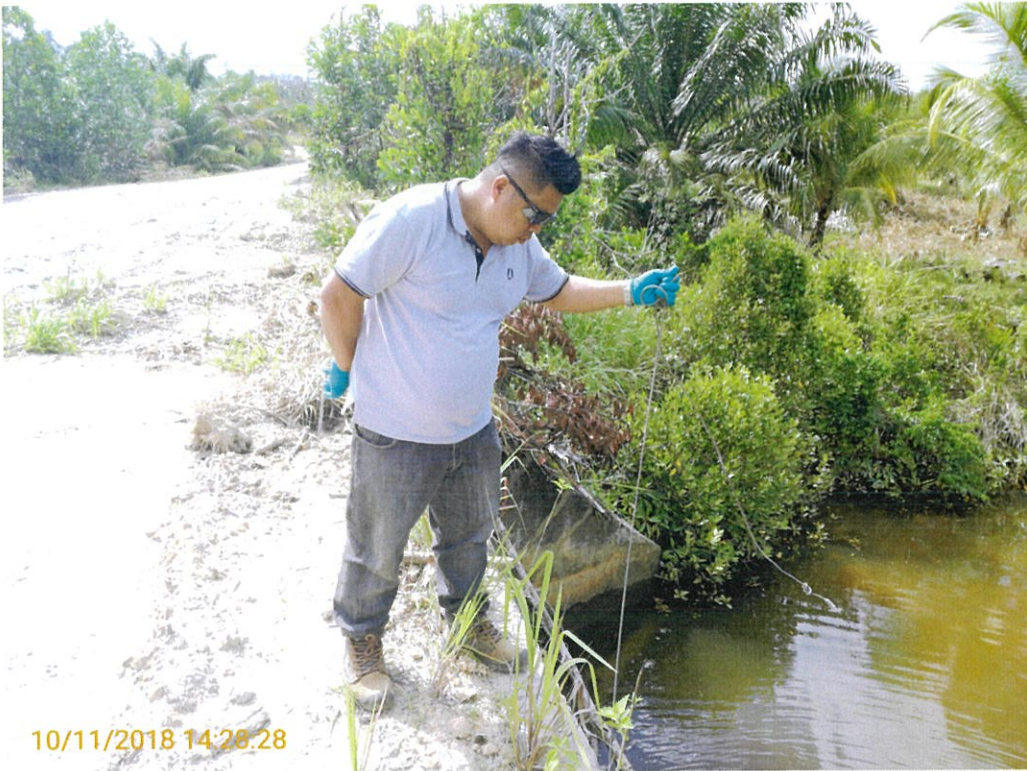
Plate 3

Water sampling exercises were conducted at monitoring station **W4**.

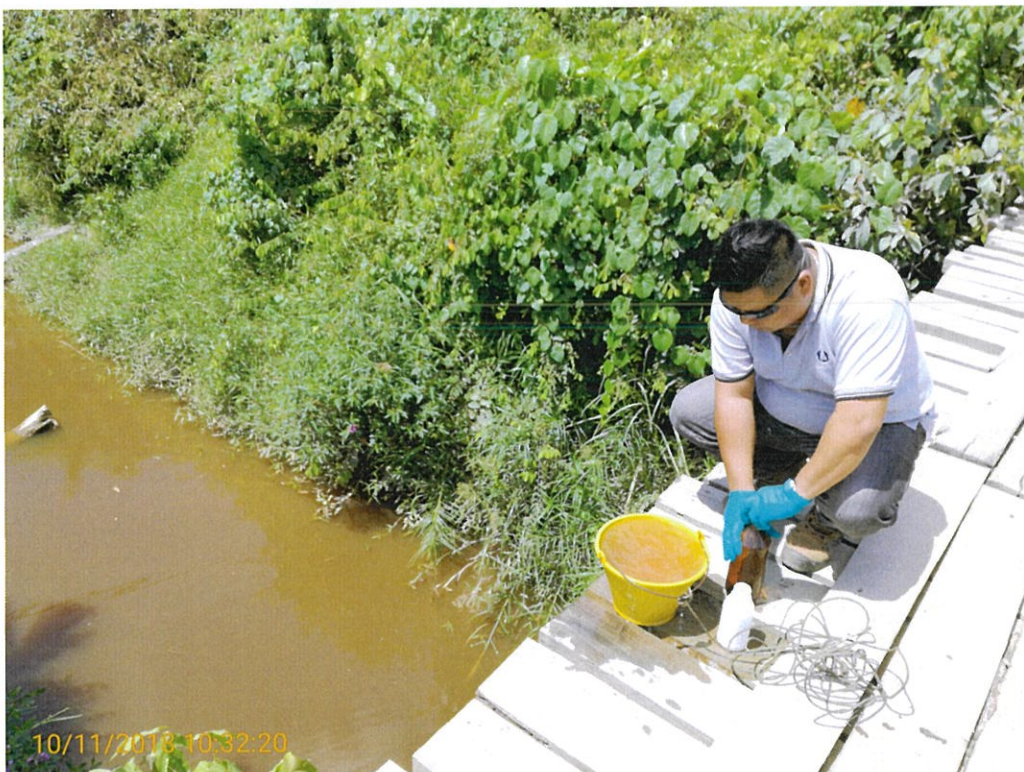
Plate 4

Water sampling exercises were conducted at monitoring station **W1**.

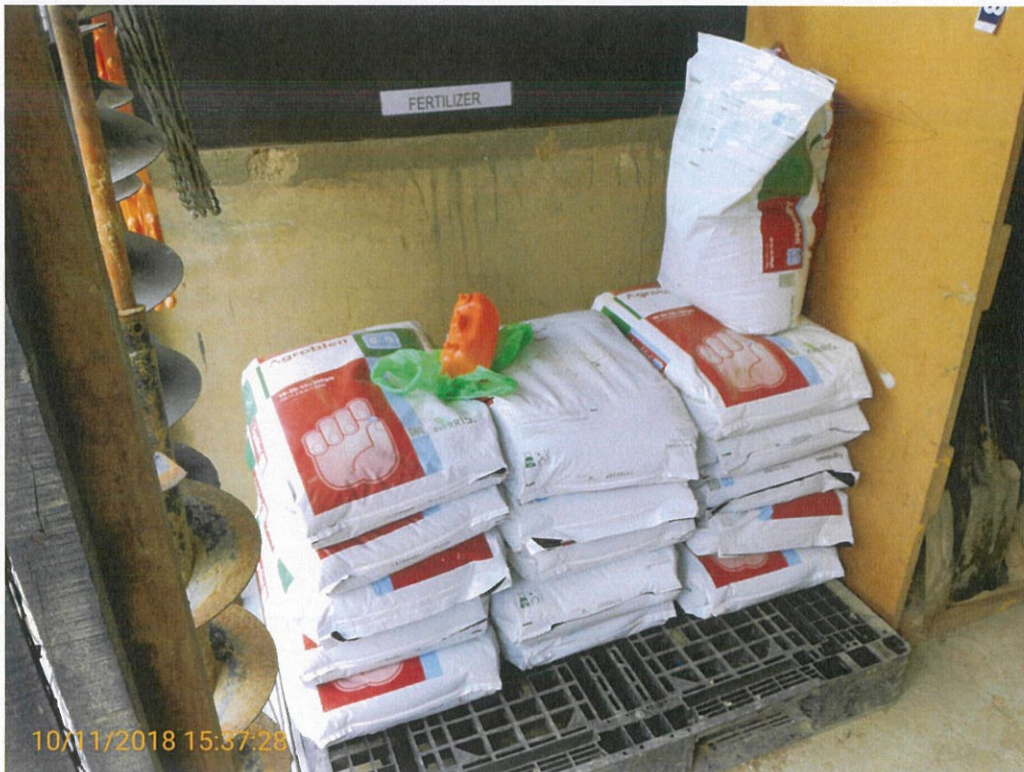
Plate 5

The fertilizer were stacked on a plastic pallet and stored at the storage area situated near the nursery area.

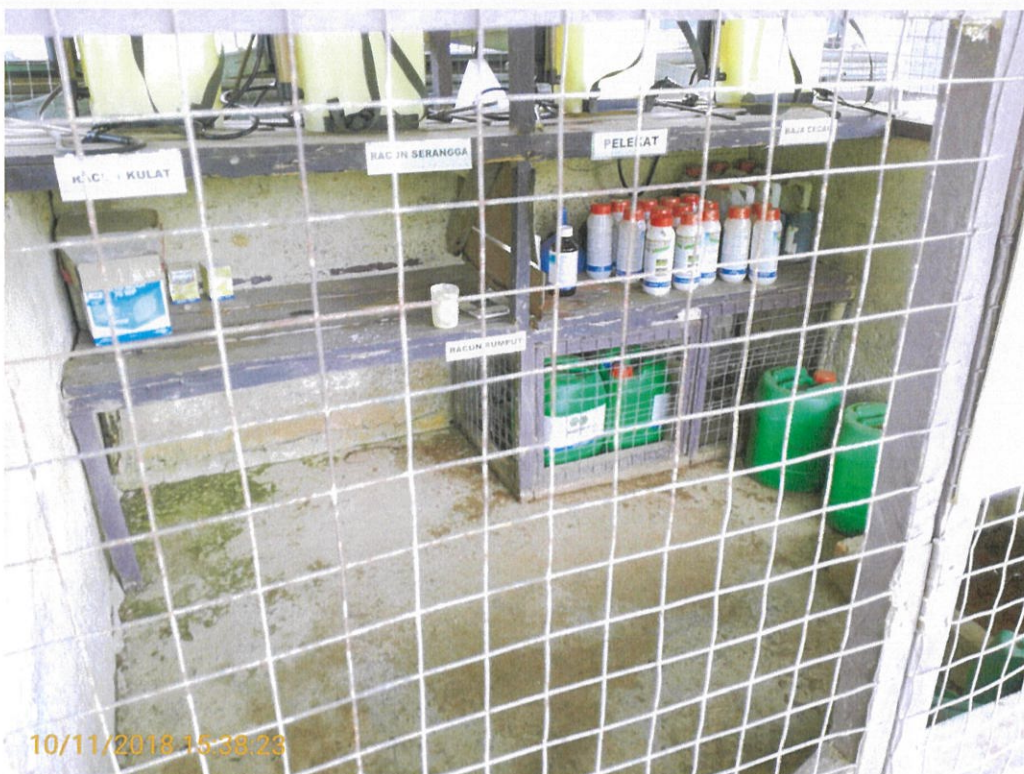
Plate 6

The herbicides and pesticides on-site were stored at the storage area situated near the nursery area.

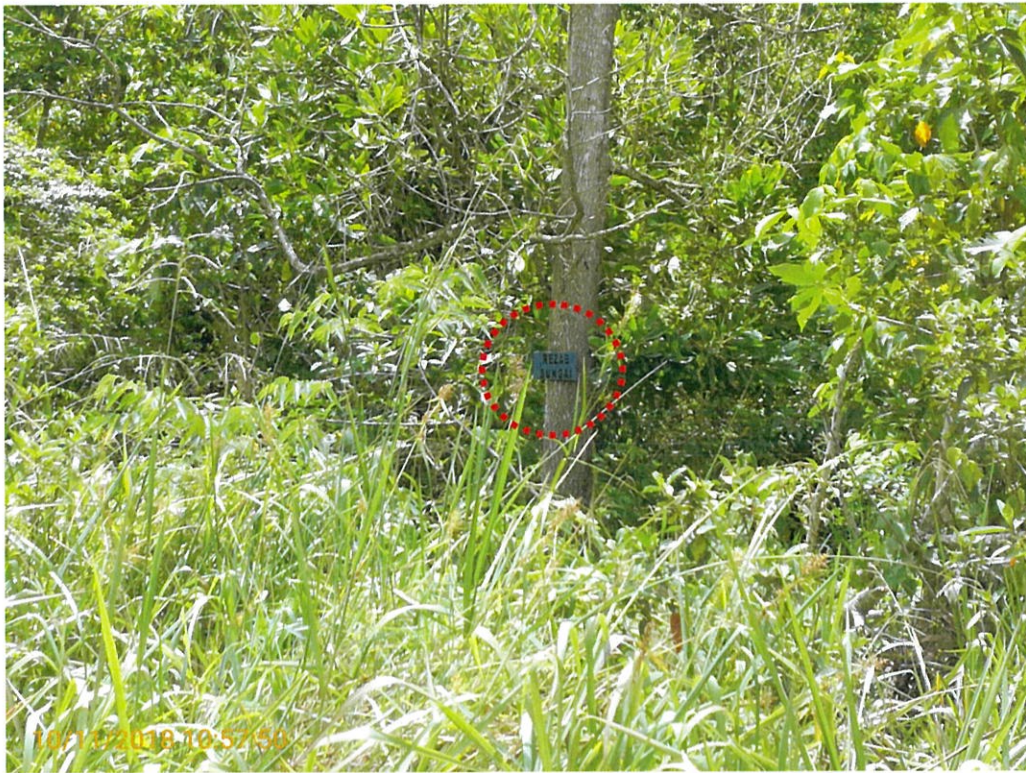
**Plate 7**

Signboard were erected to demarcate the Riparian Reserves on-site.

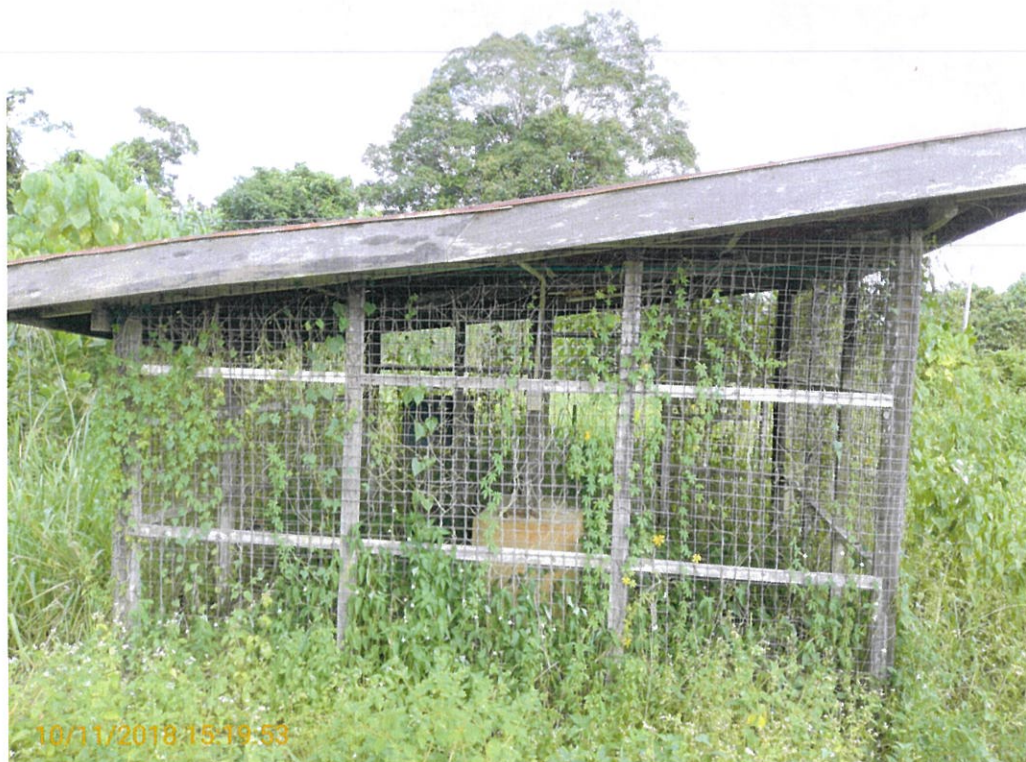
**Plate 8**

The previous water pump house which located less than 50 m away from the nearest waterways were not in used anymore as observed during the site visit.

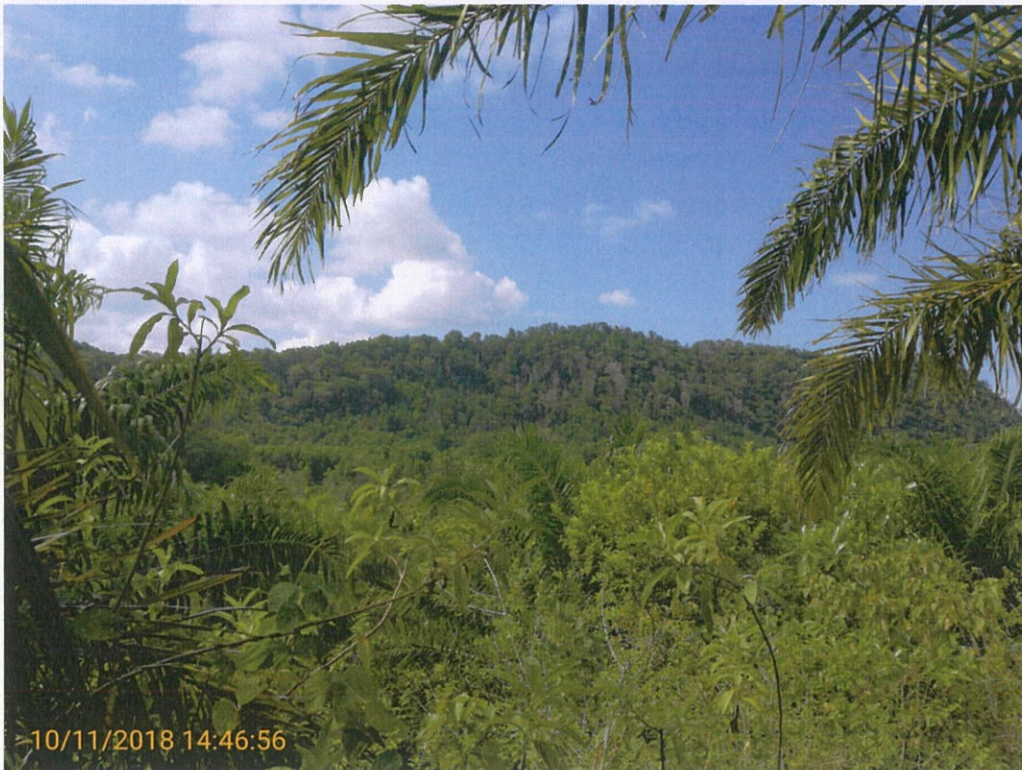
**Plate 9**

View towards the high risk area ( $\geq$ slope area) located on-site.

According to the Project Proponent, there were no signboard or any markers erected to demarcate the area as the Project has not progress into the area yet.

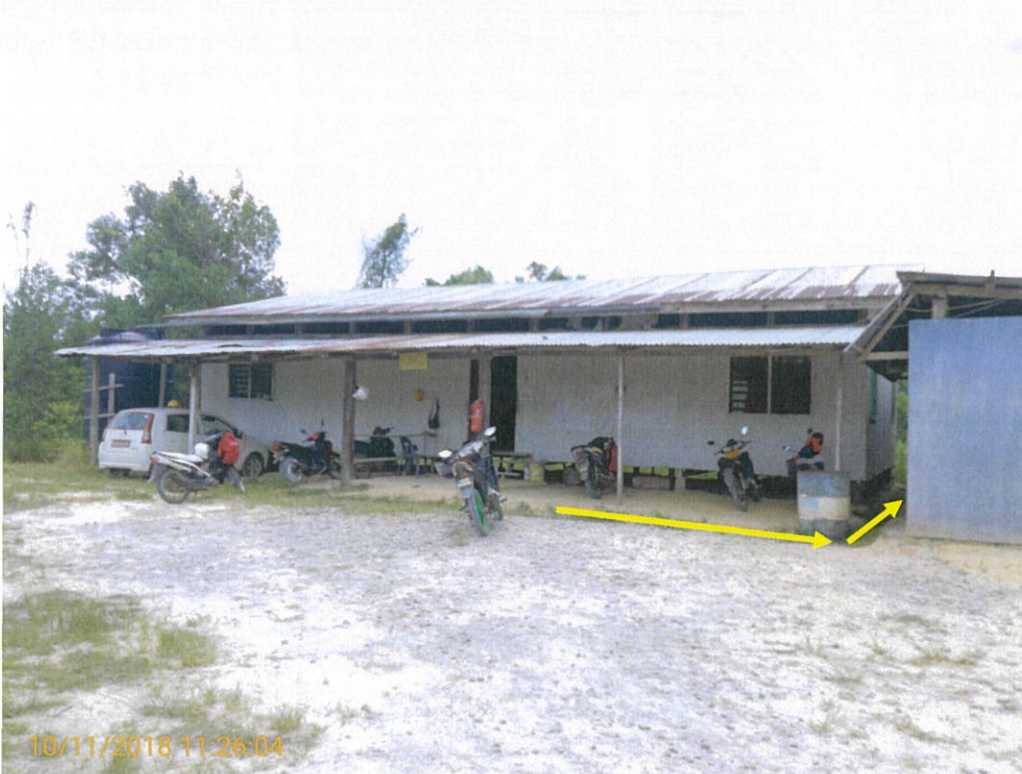
**Plate 10**

Earth drainage were provided to facilitate surface runoff.

The earth drainage were diverted towards the vegetated areas.

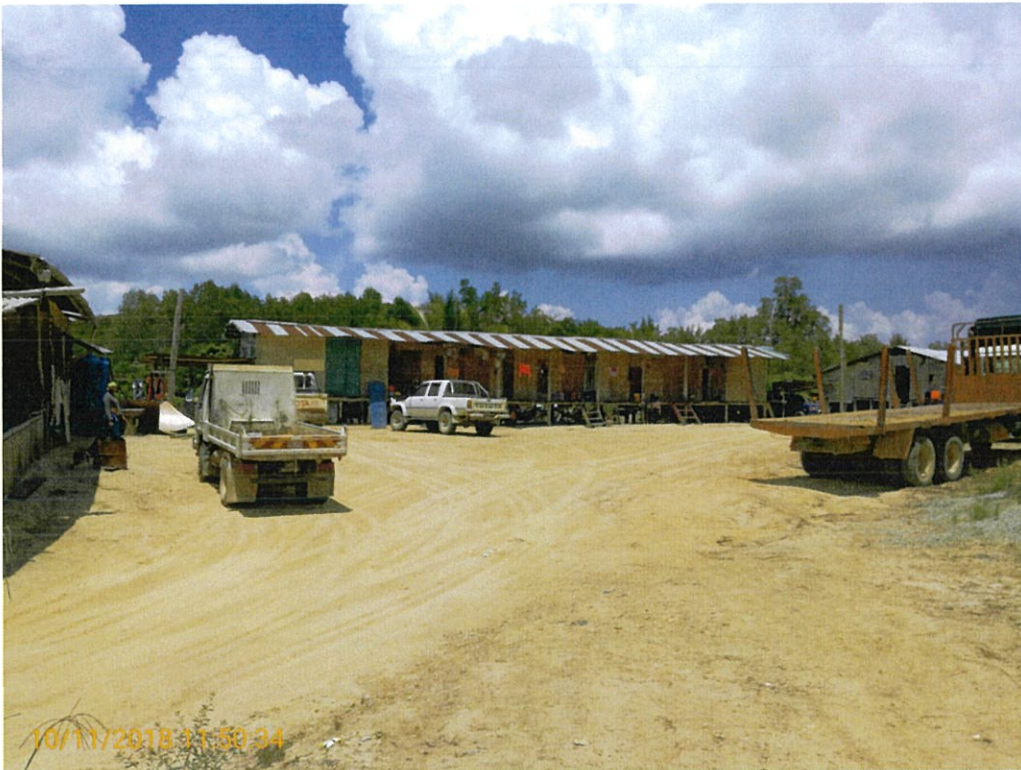
**Plate 11**

View towards one of the contractor's base camp located on-site.

The earth drainage were diverted towards the vegetated areas.

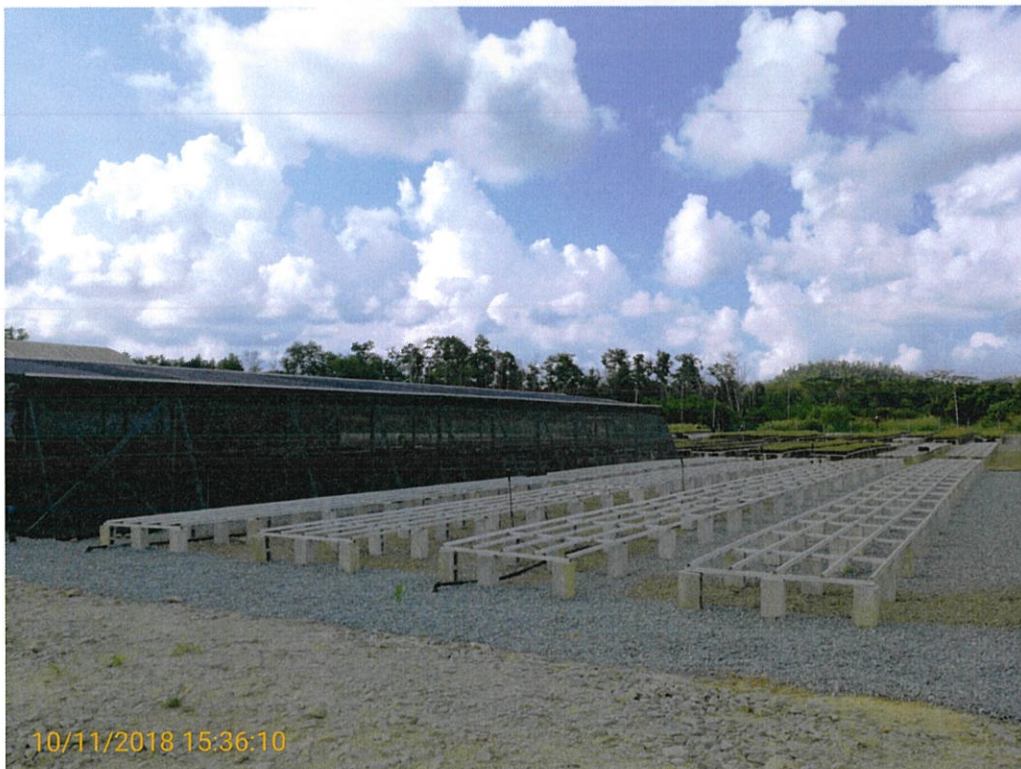
**Plate 12**

View towards the nursery located within the Project site.

The facility were located at 50 m away from any nearest natural waterways.

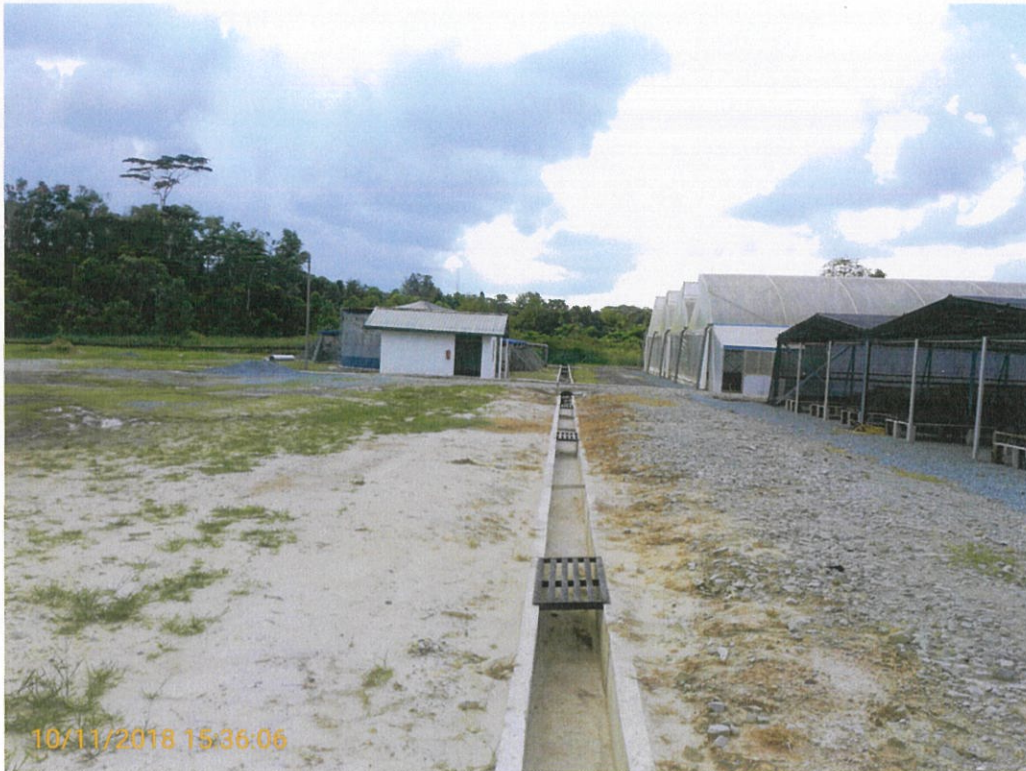
**Plate 13**

The nursery were equipped with concrete drainage that were diverted towards the nearby sedimentation pond.

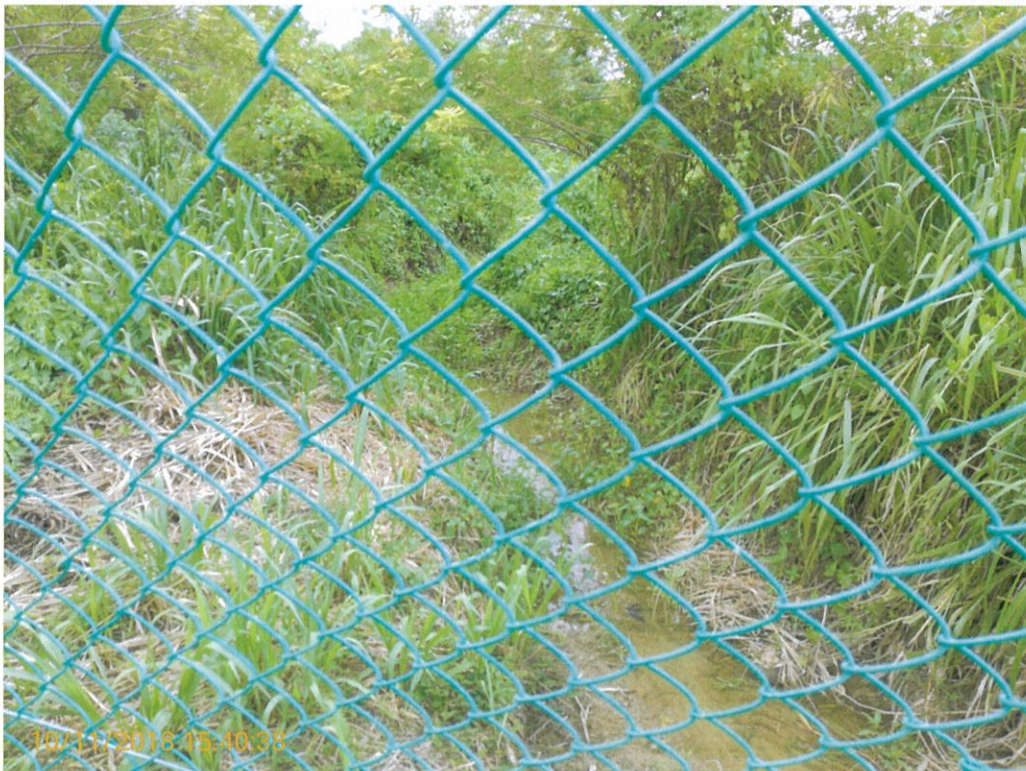
**Plate 14**

The drainage at the nursery were diverted towards the nearby sedimentation pond.

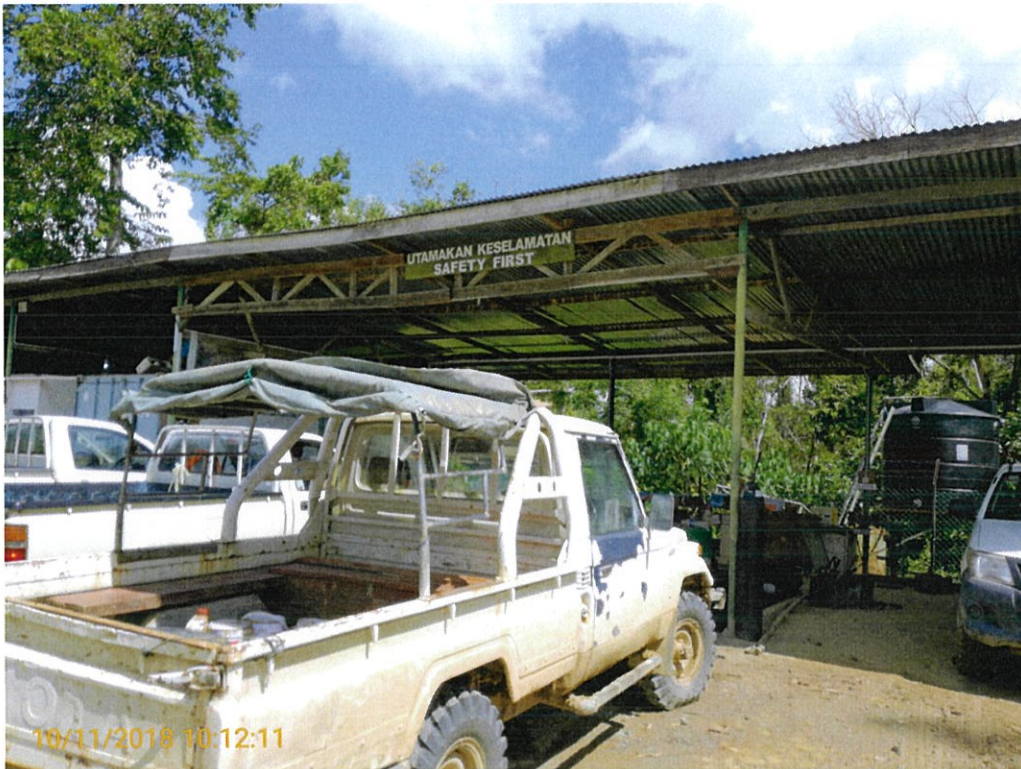
**Plate 15**

The workshop were located at more than 50 m away from any nearest natural waterways.

However, the workshop were not provided with proper drainage as observed during the site visit.

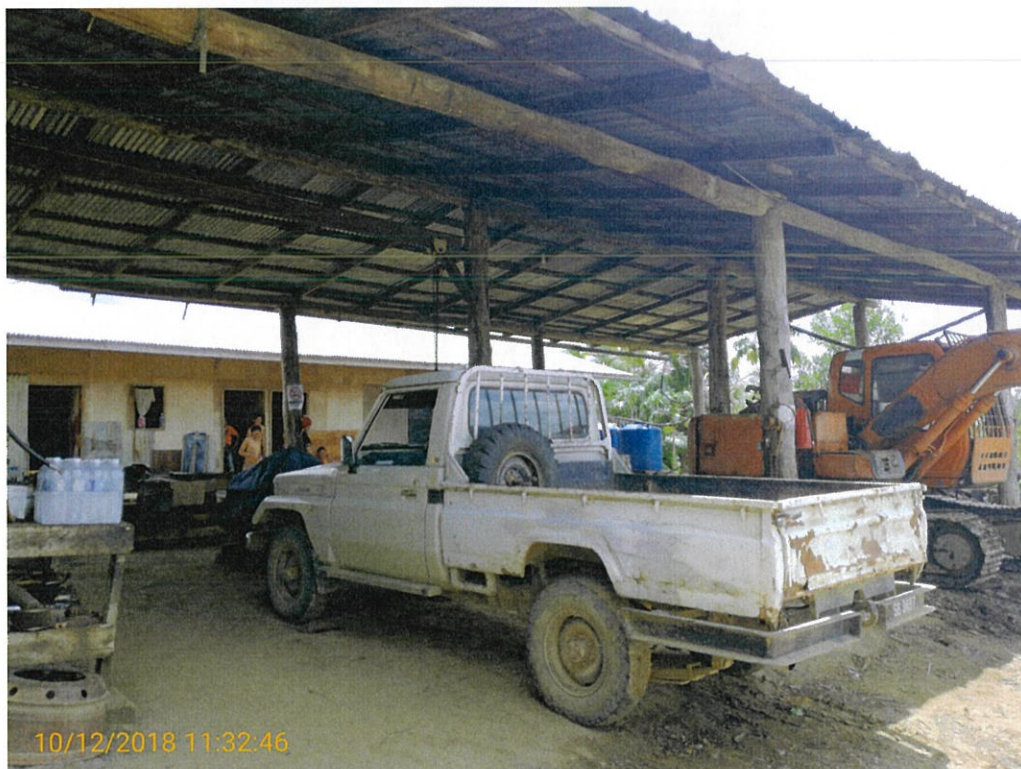
**Plate 16**

The facility were located at 50 m away from any nearest natural waterways.

However, the workshop were not provided with proper drainage as observed during the site visit.

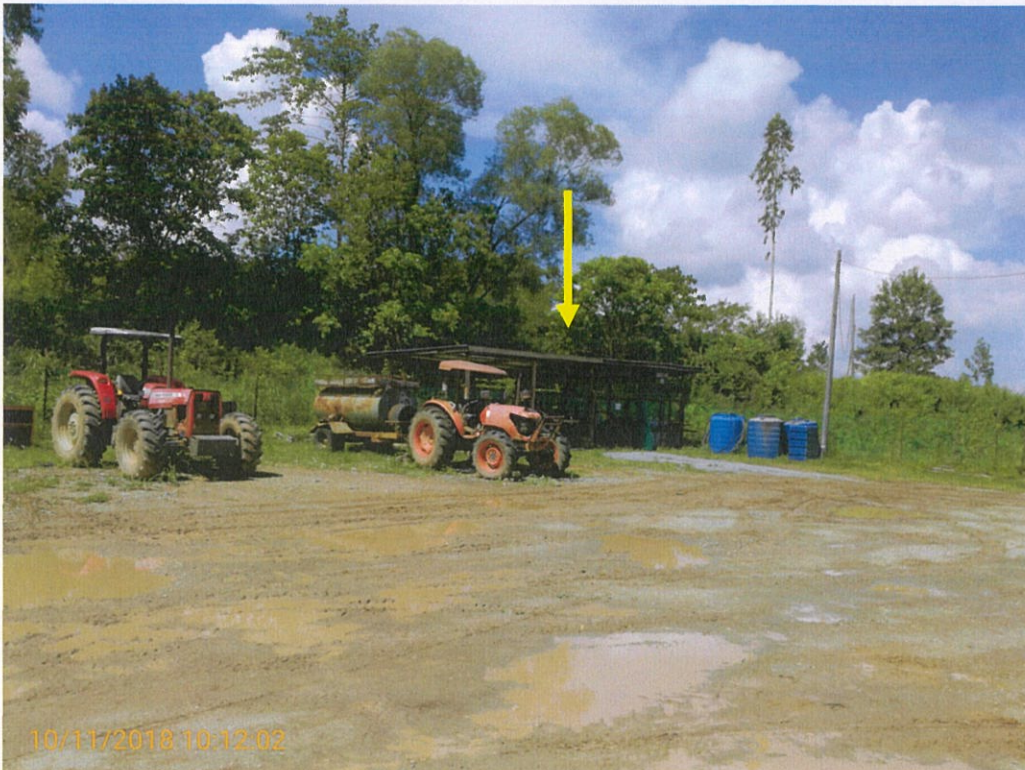
**Plate 17**

View towards the scheduled wastes storage area situated at the workshop nearby the site office.

The facility were located at 50 m away from any nearest natural waterways and sheltered from weather exposure.

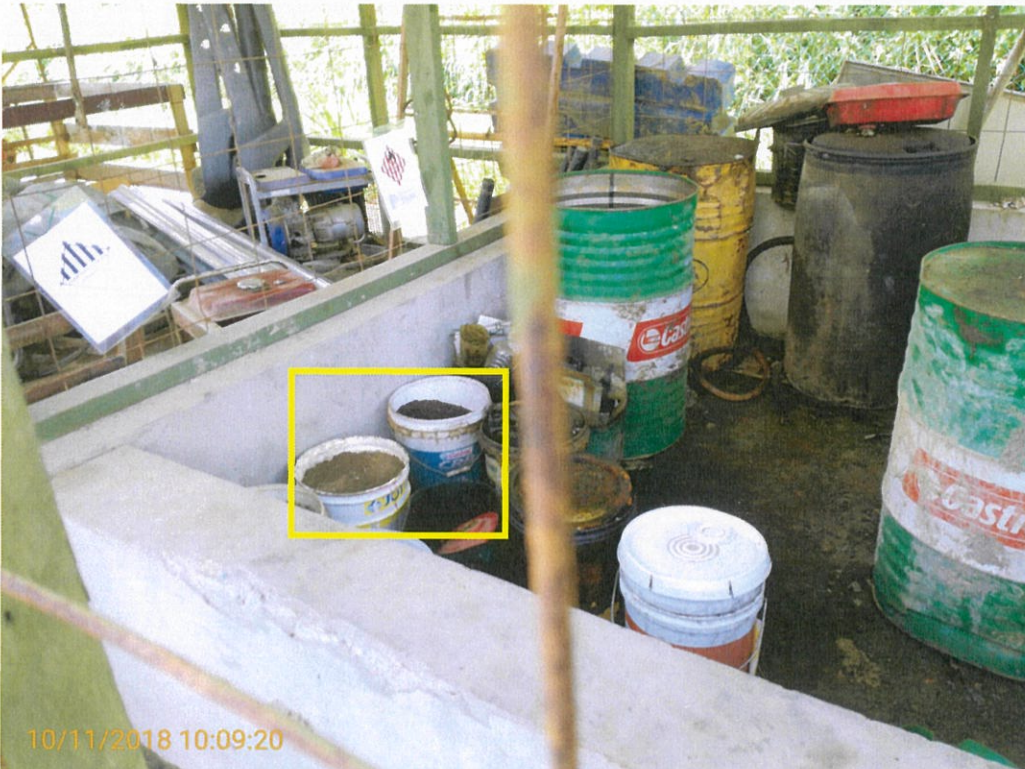
**Plate 18**

Close up view of the scheduled wastes area situated at the workshop nearby the site office.

Spillage kit (yellow box) that utilized sand were provided.

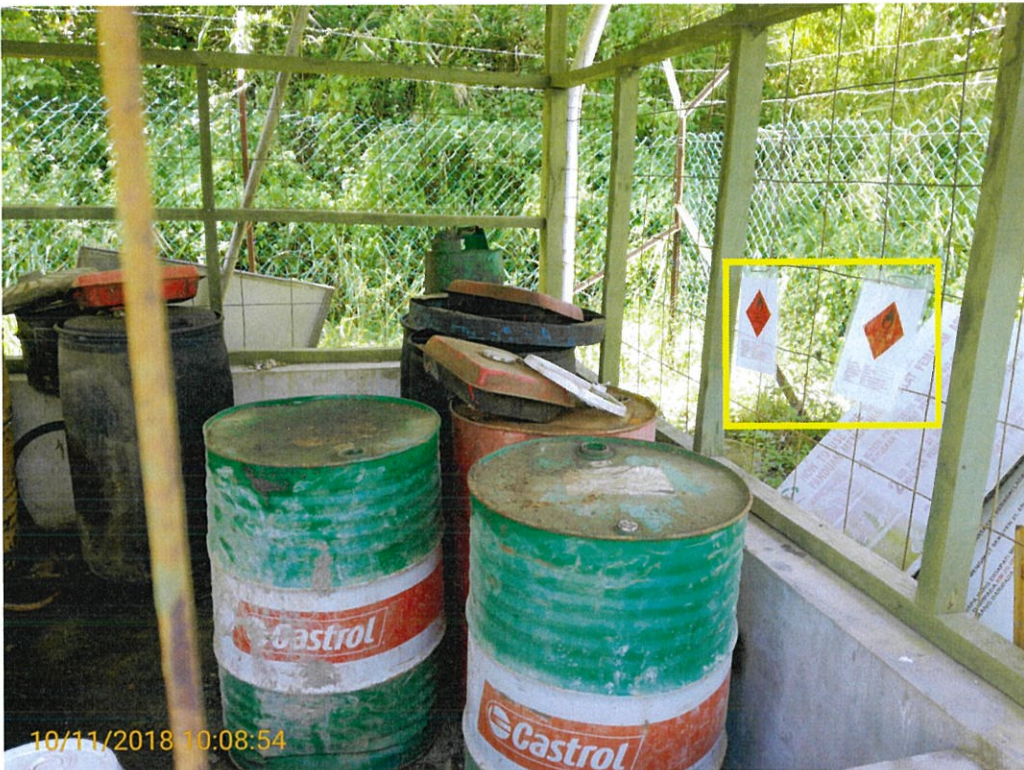
**Plate 19**

The schedule wastes on-site were labelled accordingly.

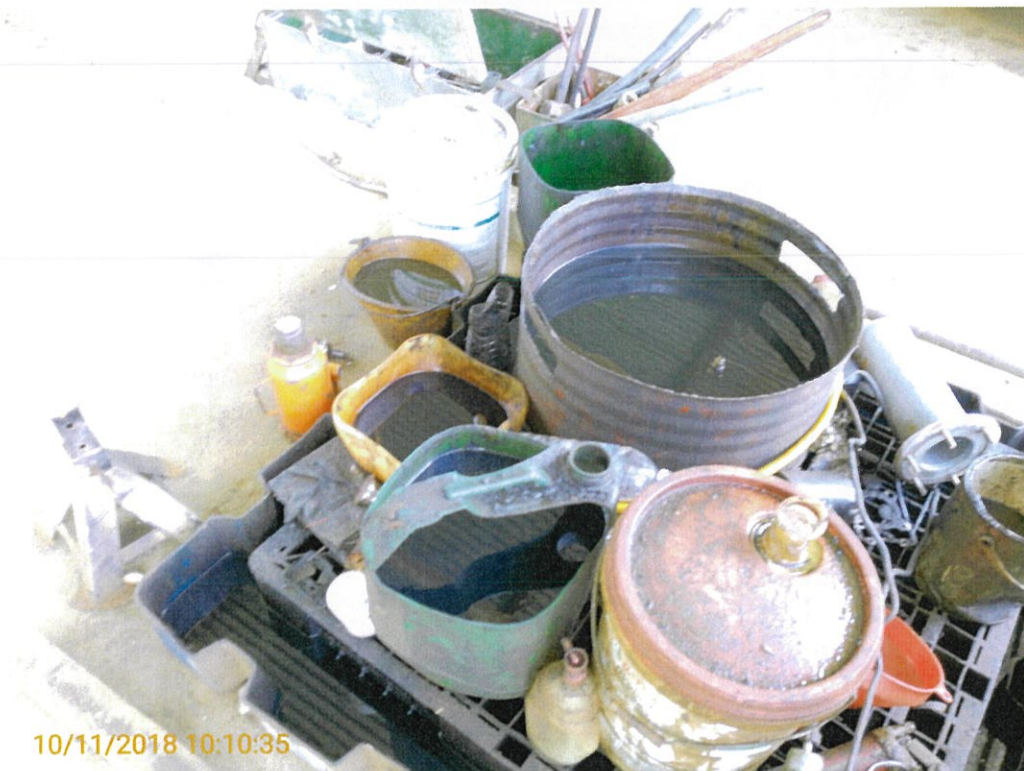
**Plate 20**

Half cut drum were utilized as drip trays at the workshop to contain any oil spill generated from \_\_\_\_\_ vehicle maintenance on-site.

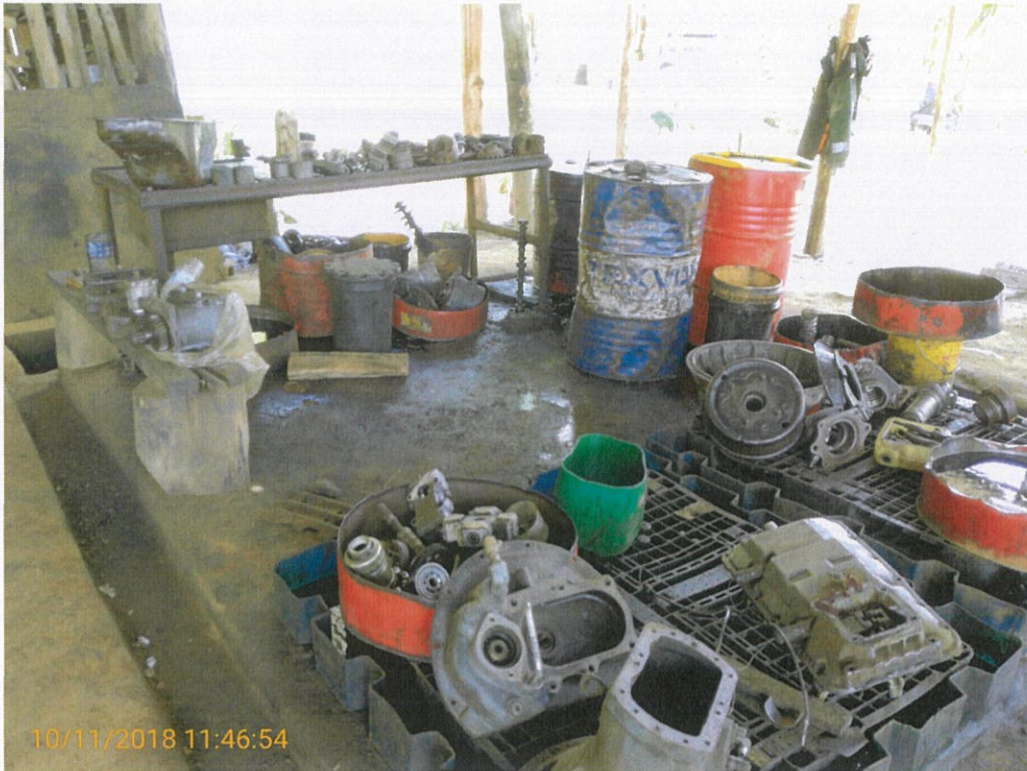
**Plate 21**

View towards the temporary Schedule Wastes storage area located at the contractor's base camp.

The facility were equipped with concretized floor and perimeter concrete drainage.

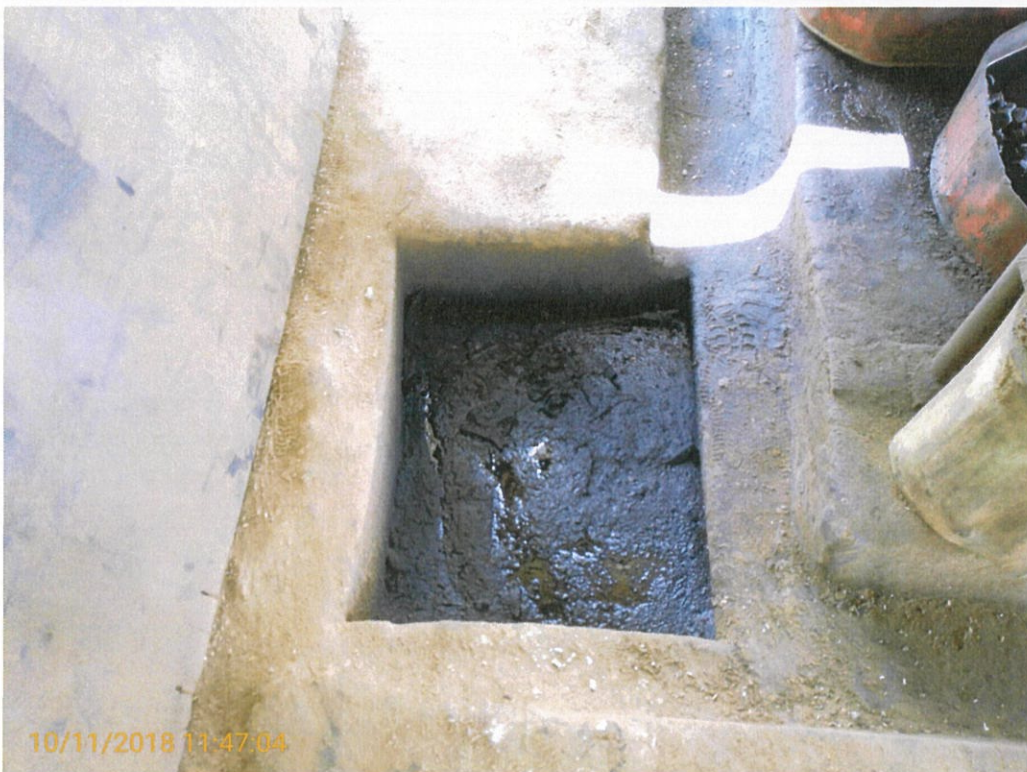
**Plate 22**

The temporary Schedule Wastes storage area located at the contractor's base camp were equipped with perimeter concrete drainage and oil trap.

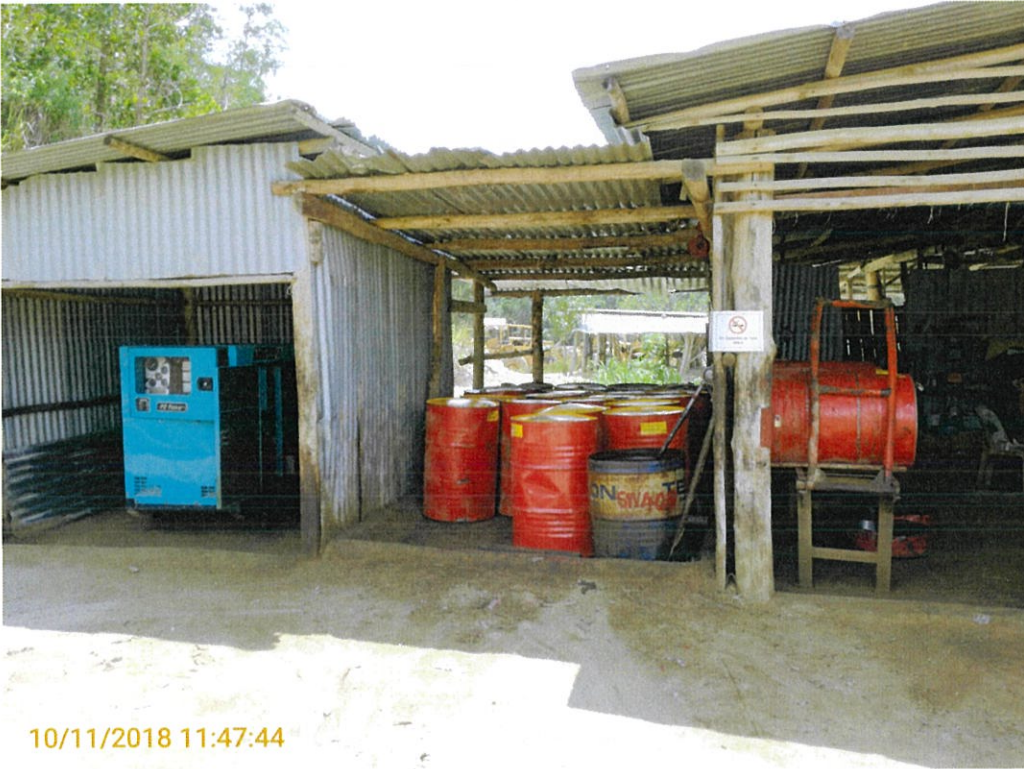
**Plate 23**

View towards one of the temporary Schedule Wastes storage area located at the contractor's base camp.

The facility was equipped with perimeter concrete containment bund, filled with sand to prevent any leakage from seeping directly into the ground.

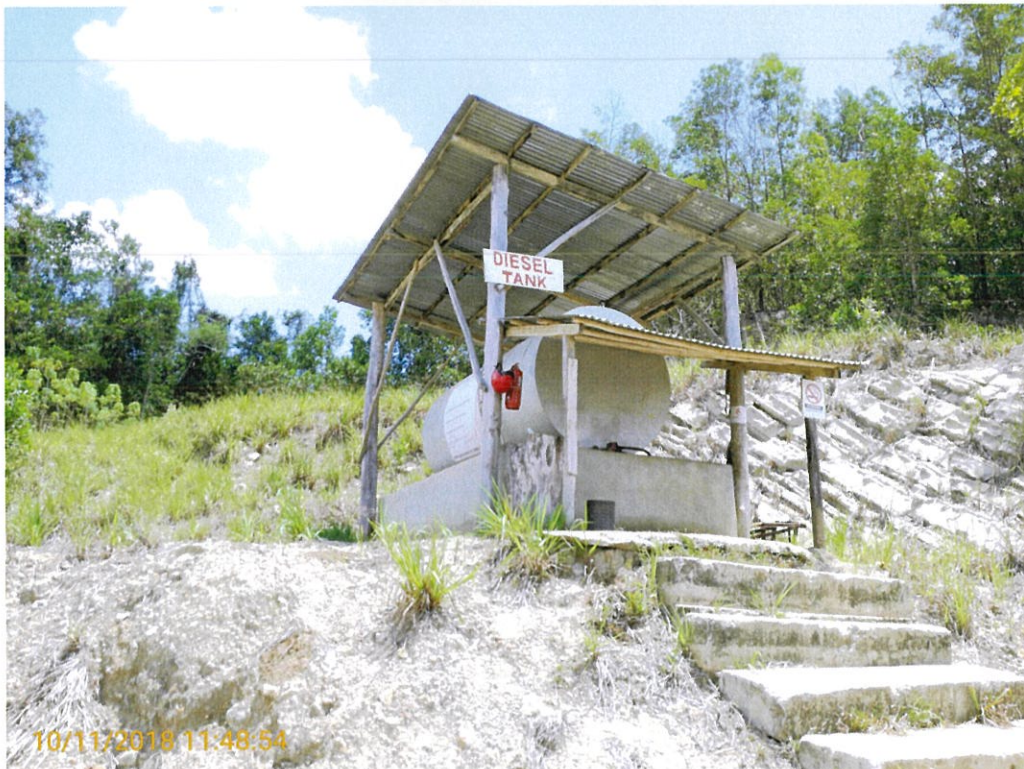
The diesel skid tank were equipped with concretized floor, bunded and sheltered from weather exposure.

The facility were located at 50 m away from any nearest natural waterways.

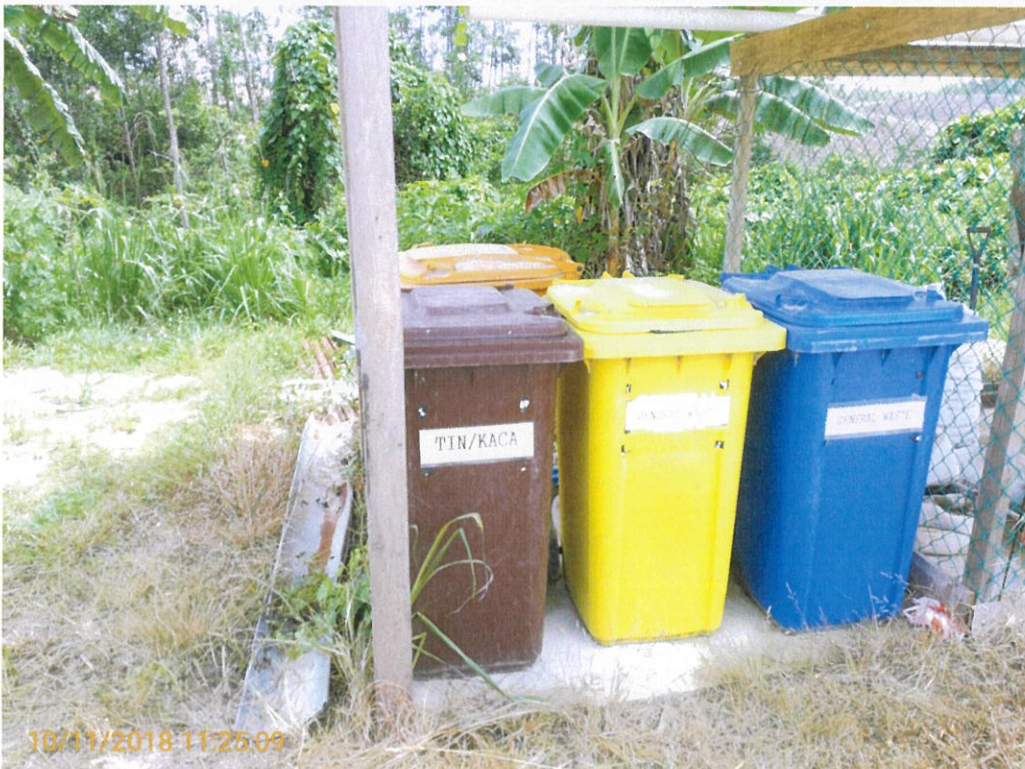
Plate 26

Recycle bins were provided at the contractor's base camp area to facilitate solid wastes segregation.

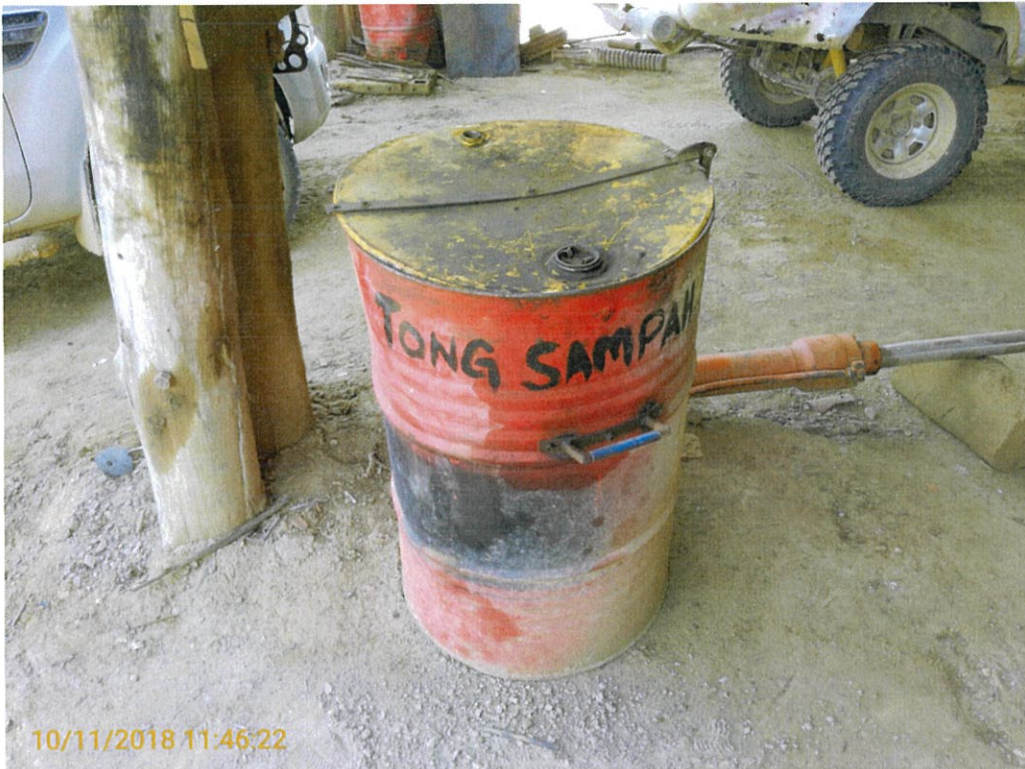
Plate 27

Old oil drums were recycled and utilized as garbage bins at the workshop area to facilitate solid wastes disposal.

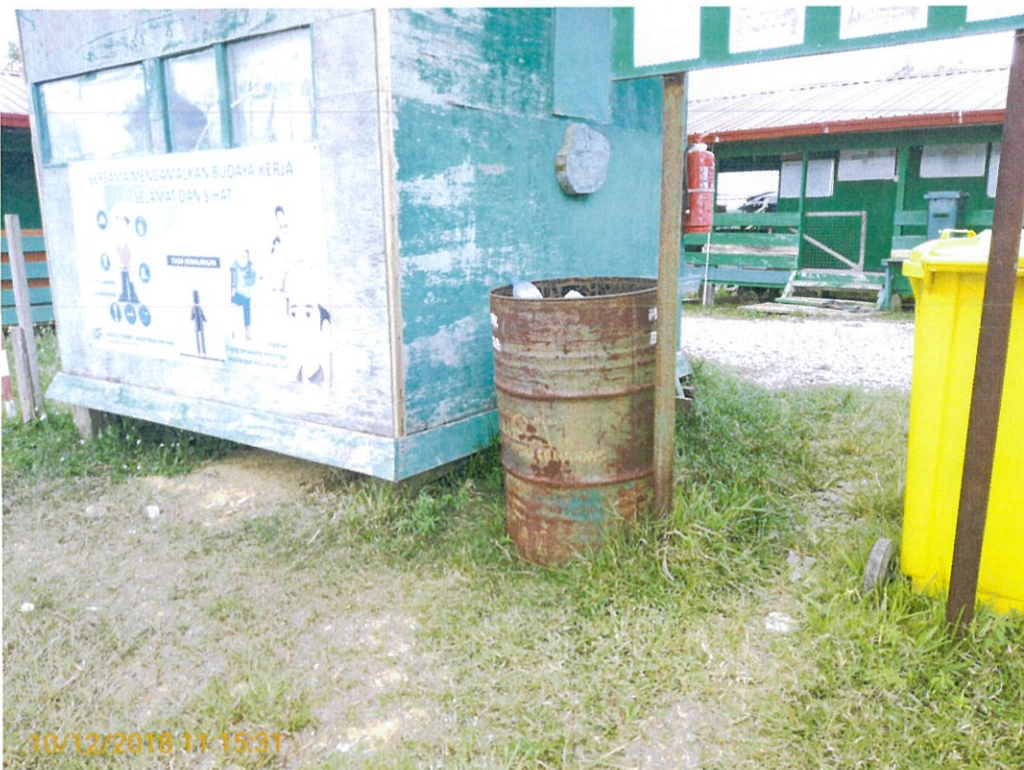
Plate 28

Old oil drums were recycled and utilized as garbage bins at the contractor's base camp area to facilitate solid wastes disposal.
