## ENVIRONMENTAL COMPLIANCE AUDIT REPORT

PROPOSED REPLANTING AND PLANTING OF 25,000 HA  
OF ACACIA MANGIUM AT BENGKOKA PENINSULA,  
DISTRICT OF PITAS, SABAH BY ACACIA FOREST  
INDUSTRIES SDN BHD.

3<sup>RD</sup> REPORT OF YEAR 2018

AEC Ref. No. : JPAS/PP/15/600-1/01/3/29  
Report Reference : CK/MO411/1188-3/18  
Date of Report : 4<sup>th</sup> December 2018

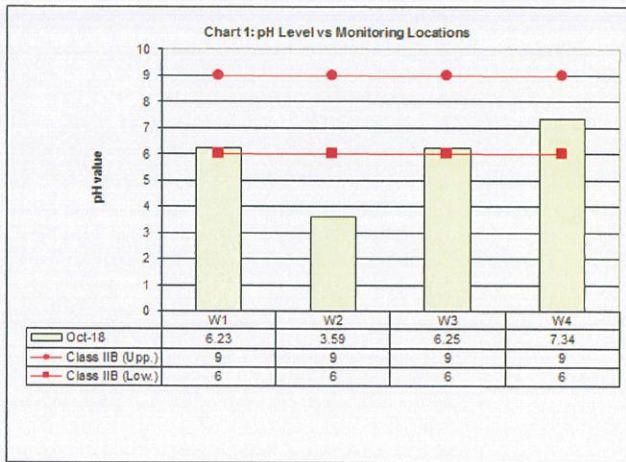
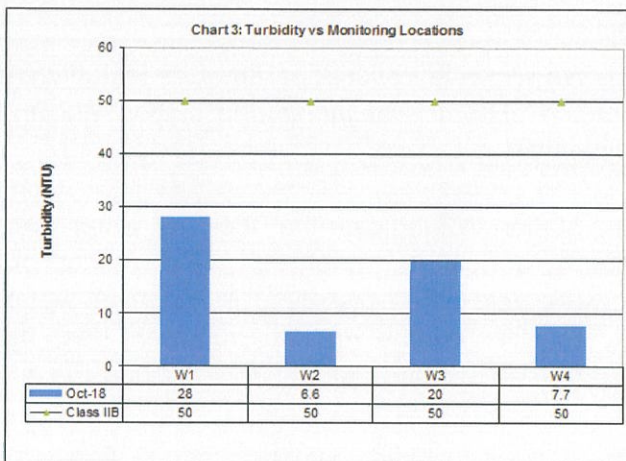
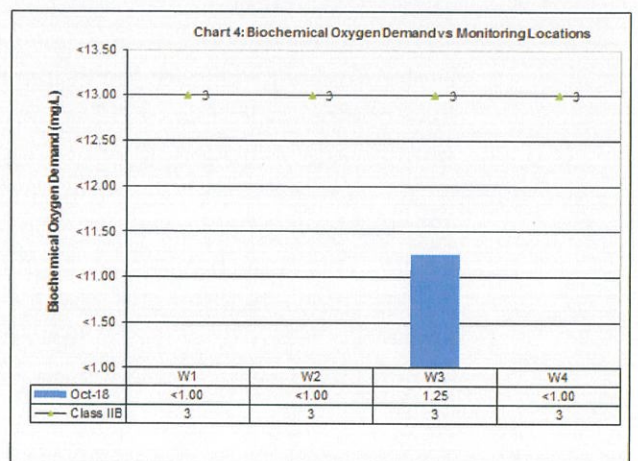
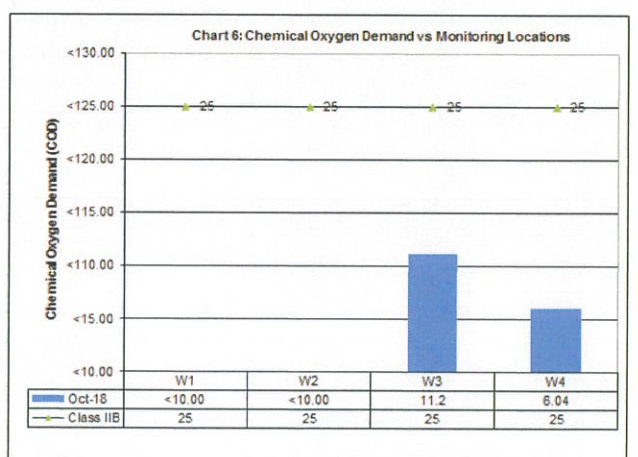
HISTORICAL WATER QUALITY RESULTS (W1 – W4)

Water quality results for locations **W1** – **W4** show that overall parameters tested were fully comply with **Class IIB** except for the pH value at monitoring station **W2** and Ammoniacal-Nitrogen at monitoring station **W1**.

The low level of pH value at monitoring station **W2** indicate that the river water were acidic. This may be caused by the nearby agricultural runoff that were washed out during rainy weather and creates a weak acid when dissolved in the river water. However, there were no signs of any activities by the Project Proponent near the existing waterways or within the Riparian Reserves area as observed during the site visit.

The high level of Ammoniacal-Nitrogen (NH<sub>3</sub>-N) at monitoring station **W1** could be contributed by the surface runoff flowed from upstream of the sampling location which brought out decayed plants and animal composition.
