Hydrological Assessment Report

Acacia Forest Industries Sdn Bhd (AFI)

For Acacia Forest Industries Sdn. Bhd. (AFI)

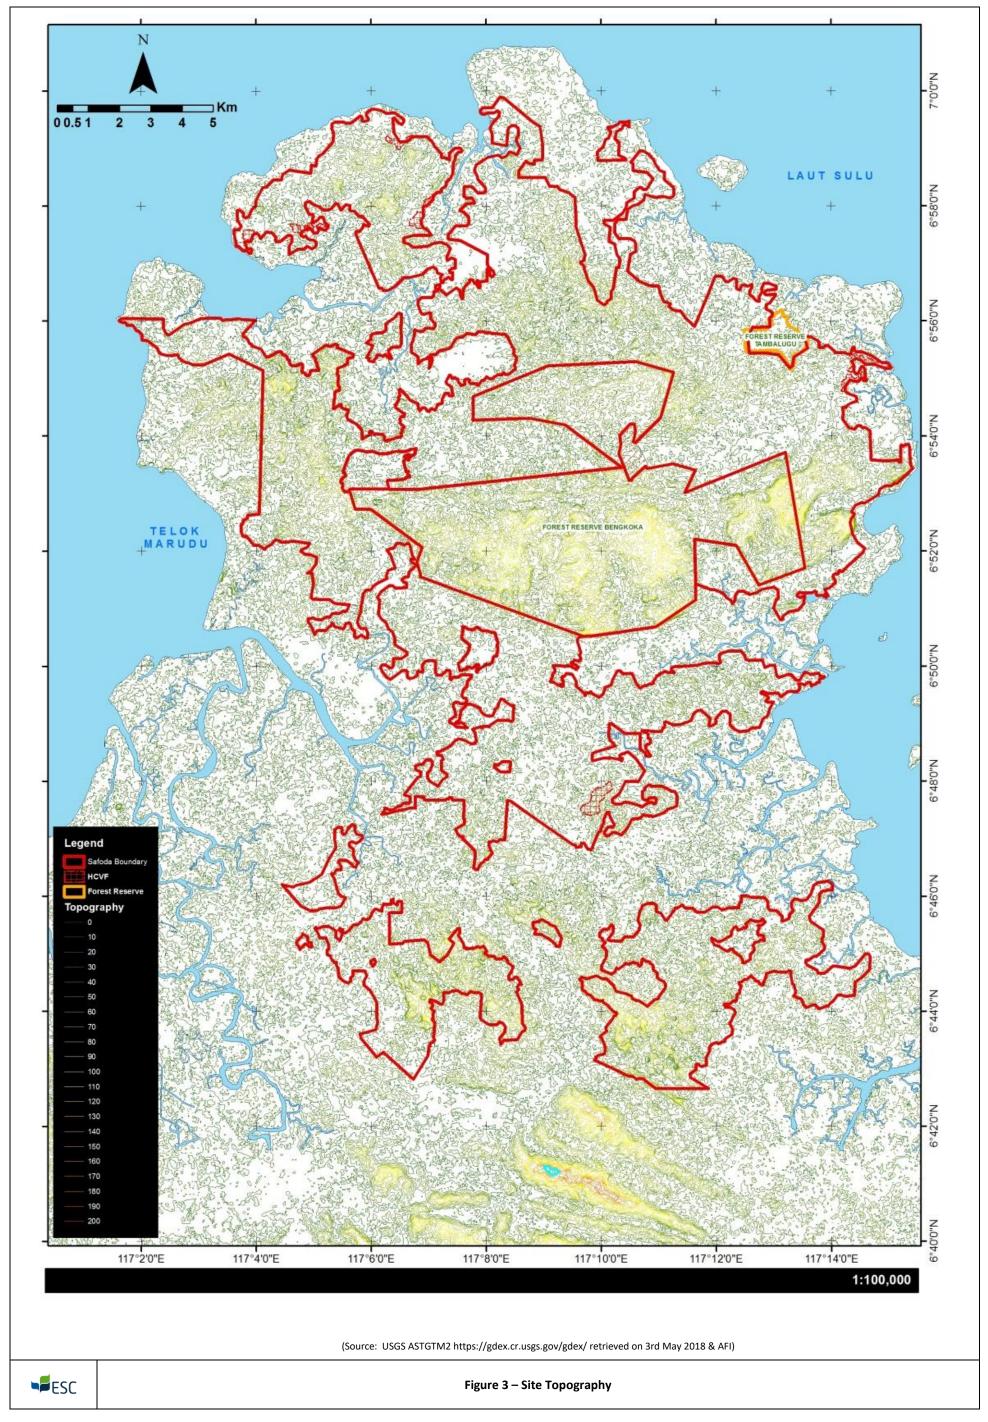
Topography in surrounding AFI areas based on GIS modelling on DEM from ASTGTM2 (N06E&07E117) is presented in Figure 3 below.

About 99.8% (24,720 ha) of the total project site land is formed with \leq 25° slope. Only 0.2% (49 ha) of the site area has steep land over 25° slope. The site topography is generally undulating hills ranging from 30.48 m to 60.96 m Above Mean Sea Level (AMSL) (*Figure 3*). Based on the site visit, several areas identified as plantation areas were seen in different stages i.e clearing, planting, full grown and ready for harvesting, as well as post plantation stages.

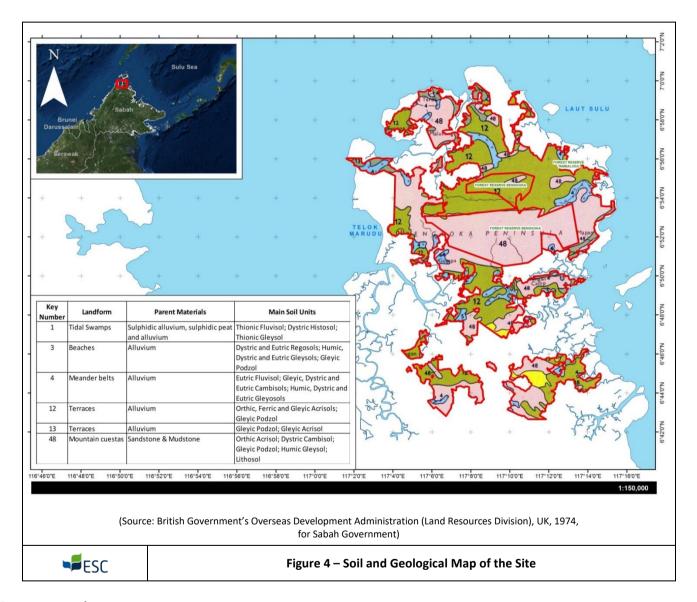
As shown in *Figure 4*, most of the site falls within the Kudat Formation and Bongaya Farmation, with a small portion of South Banggi Formation as well as coastal & riverine alluvium. Kudat Formation is an Oligocene strata and consists of mudstone, sandstone, shale, siltstone, conglomerate and limestone. Bongaya Formation comprises sandstone, mudstone, siltstone, shale, conglomerate and lignite with minor limestone and tuff. In terms of soil formations, Maliau and Lokan Associations are the dominant soil within the project site with mudstone and sandstone as its parent materials. These associations occur on the mountain cuestas. The minor soil associations are Brantian and Tuaran Associations with alluvium as their parent material.

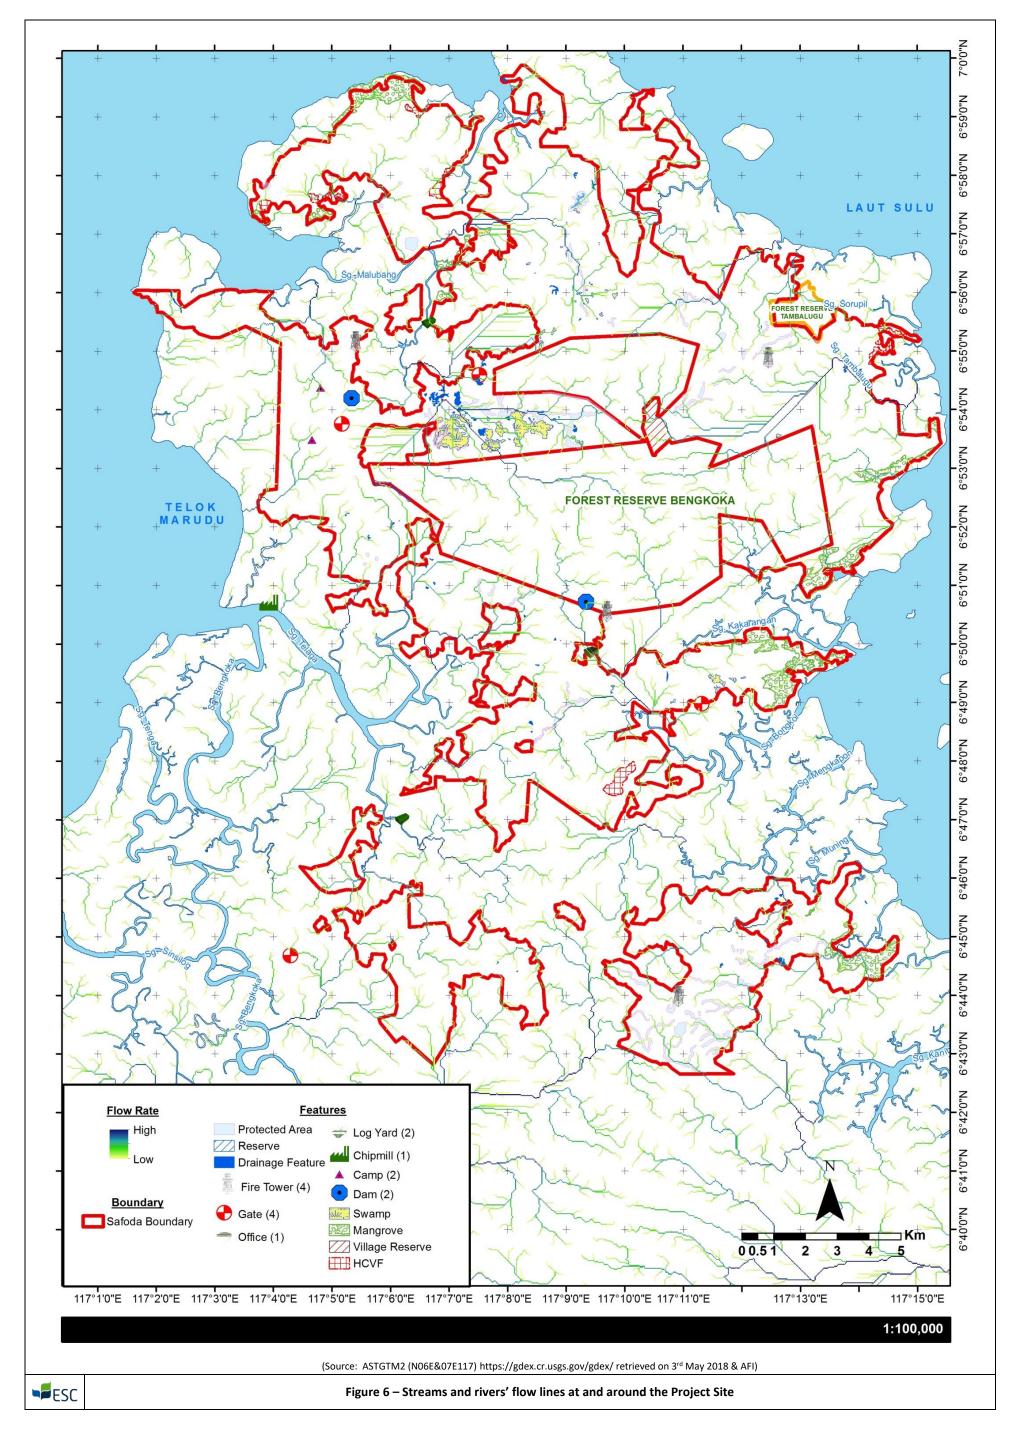
The streams and river flow lines within and in the surrounding AFI areas based on GIS modelling on ASTGTM2 (N06E&07E117) is presented in *Figure 6* below.

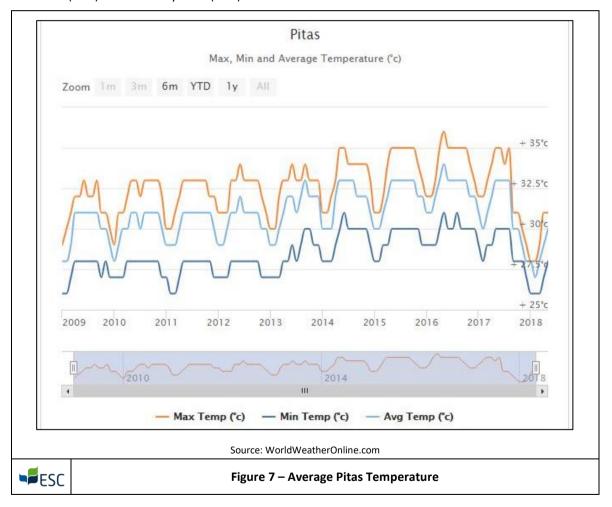
Temperature trends from January 2009 to May 2009 illustrated in *Figure 7* below shows average temperatures of Pitas district ranging from a minimum of 26°C (2009) to maximum of 36°C (2016). Further analysis of the graph shows a repeated trend of increase in temperature in June and September and decrease temperature from the months of January to February.

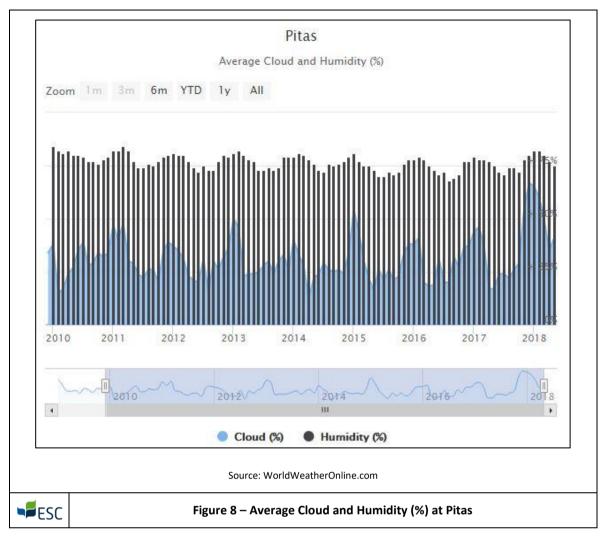
Change in temperature is relative to the change in humidity. Data presented in *Figure 8* is the average humidity from January 2010 to May 2018. Lowest humidity at 68% was recorded in August 2016 while the higest was in January 2010 at 84%. The graph, however, recorded that cloud cover in December 2017 as maximum (67%) and February 2010 (15%) as minimum.

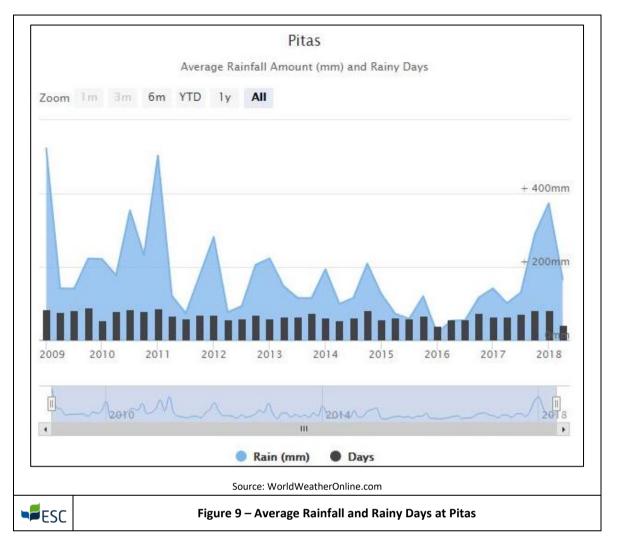
The rainfall data in *Figure 9* illustrates the average rainfall data and rainy days from January 2009 to May 2018. The record indicated unsimilar pattern of driest and wettest months of each year. The web recorded that the lowest average rainfall amount was occurred in January – March 2016 (19.7 mm) however, in the same period of months in 2009 the highest average rainfall amount was also recorded (522.9 mm). This pattern may occur due to climate changes phenomenon.

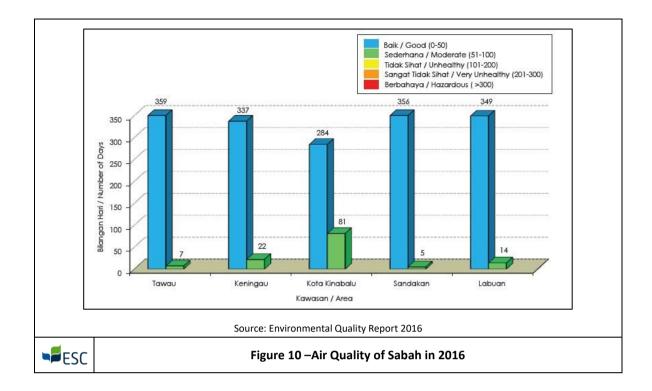
Air quality status is reported in terms of Air Pollution Index (API) where the API is calculated based on the concentration of five major pollutants which are ground level ozone (O_3) , carbon monoxide (CO), nitrogen dioxide (NO_2) , sulphur dioxide (SO_2) and particulate matter of less than 10 microns in size (PM_{10}) . The API is categorised as good, moderate, unhealthy, very unhealthy and hazardous. There are no industrial areas that producing dangerous discharge to the air within 5 km from the project site therefore, no major sources of air pollution in the surrounding area. Based on the DOE's Environmental Quality Report, 2016, the nearest location of Continuous Air Quality Monitoring (CAQM) station is at Kota Kinabalu (± 152 Km) and Sandakan (± 154 Km). The air quality in both CAQM was ranging from good to moderate as shown in *Figure 10* below.

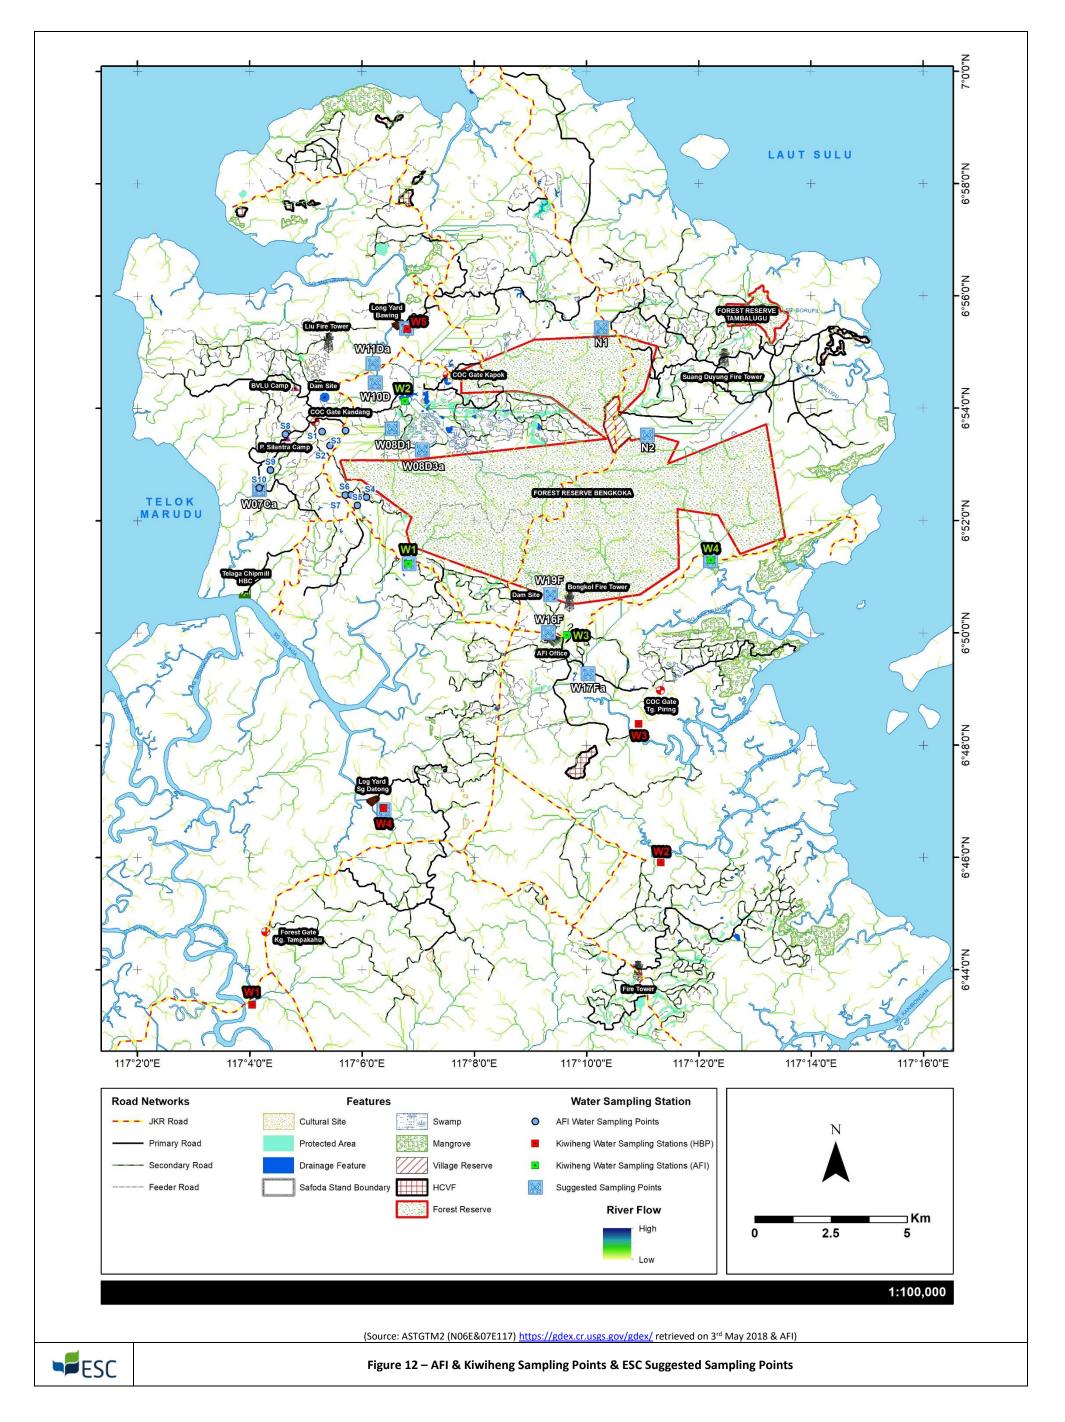
- AFI sampling points, namely S8, S9 & S10 that were used to monitor water conditions in
 plantation area at Telok Marudu river system are still observed to be located in active area. In
 this study, sampling point W06Ca was located at S8 while W07Ca was located at S10. However,
 as W06Ca/ S8 was observed not located in upstream of the river system therefore, the
 recommendation is to find the upstream, namely N5 at KGLI05/ KGLI06/ KGLI09 then use
 together with S10 as monitoring points for Telok Marudu river system. Due to this uncertainty,
 exact location of N5 is not shown in Figure 12.

Based on the desk review and the ESC site assessment conducted on 14th – 16th May 2018, ESC has recommended AFI to establish new sampling points and discontinue the use of some of Kiwiheng's sampling points except for the points that are located upstream of plantation areas which are still deemed relevant. Therefore, based on current AFI active areas, ESC concludes the following:

- Sampling points for Kiwiheng AFI, namely W1&W4 (Sg Telaga and Sg Kakarangan river system) are located in non-active area however, these sampling points can be used to monitor water quality that coming from southern part of Bengkoka Forest Reserve (BFR) where Gerak Saga Sdn Bhd is operated. Sampling point W3 is replaced with W19F, W16F, and W17Fa to monitor water quality of river system F (Sg. Bongkol) while W2 is replaced with W08D1 to monitor water quality at Bodu area that coming from Kg. Kandang, and Kg Kodong.

- In addition to Kiwiheng AFI sampling points, additional monitoring points at the northern part of BFR are required to be established. The recommendation for these additional monitoring points is to use W08D3a, W10D, and W11Da in northwest part of BFR and to establish new monitoring points to monitor the northeast part of BFR. This is important as northeast part of BFR is started to be developed as plantation areas (Kg. Maringan and Kg. Suang Duyung) in 2019. Suggested points to monitor upstream water quality of AFI plantation in northeast part of BFR are N1 which to be located at stream that flows to Kg Maringan and N2 at stream that flows to Kg. Suang Duyung. Approximate location of N1 and N2 are shown in in Figure 12. Map of streams and river line in surrounding AFI areas (Figure 6 and in Figure 12) shows that suggested location of N1 is part of Kg. Maringan river system while N2 is part of Sg. Tambalugu river system. As to serves its function, sampling at N1 & N2 should be started prior to land preparation in Kg. Maringan and Kg. Suang Duyung.

- Kiwiheng-HBP sampling points W1 & W2 (Sg Bengkoka & Sg Mengkapon river system) are
 located in non-active area hence not suitable for monitoring purposes. However, W4 & W5 may
 still be used to monitor water quality near the log yard. Sampling point W3 is suggested to be
 replaced with W17Fa to give a better description on water quality at downstream of Sg. Bongkol.

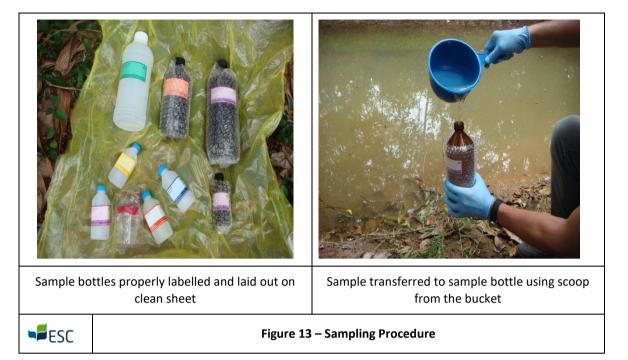
Probe immersed in waterbody to take water condition readings

Bucket is used to collect water from waterbody

- 5. Cooler box filled with sufficient amount of ice for preserving the sample was prepared before the sampling.
- 6. Before collecting water samples, in situ water condition readings were taken using AMK, AM 2000 multiparameter probe to measure in-situ water quality parameters such as DO. (mg/L); EC. (uS/cm); TDS. (mg/L); Turbidity (NTU); Salinity (ppt); SSG. (ot); pH; ORP. (mV); and Temperature (°C). The probe was immersed directly into the waterbody. All measurement were recorded in water log forms for further recap. RO water was used to wash and rinsed the probe before use as to ensure quality of readings.

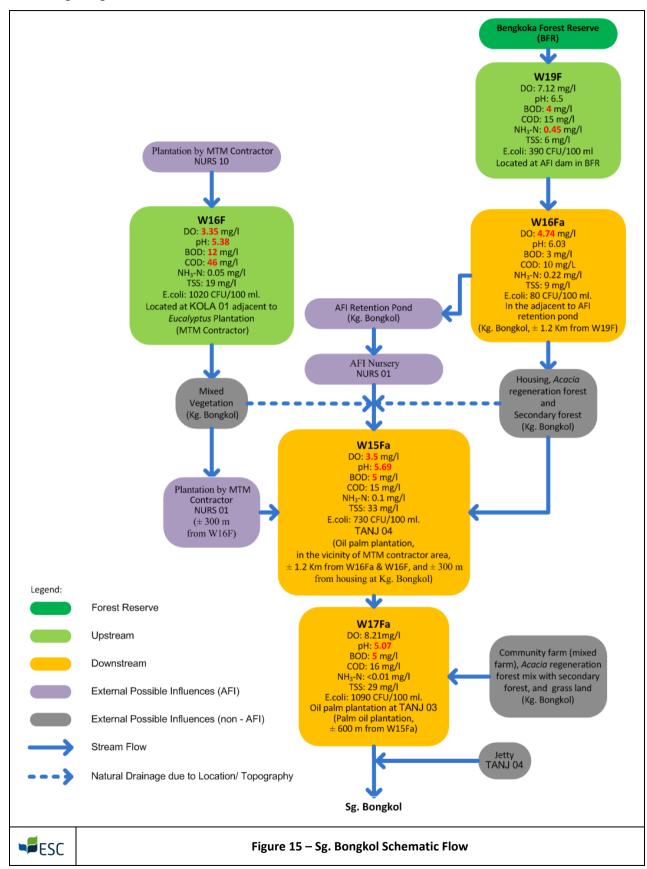
6.2.1 Sg. Bongkol Schematic Flow

The upstream sampling locations for Sg. Bongkol river system were taken from 2 locations namely Safoda dam in BFR (W19F) and a waterbody that flows from the plantation area managed by MTM contractor at NURS 10 (W16F). As shown on Figure 11 these locations are influenced by the BFR and plantation area at KOLA 7 (MTM).

Water from Safoda dam (W19F) was observed to have high level of BOD (4 mg/l) and NH₃-N (0.45 mg/l). As this location is within the BFR, the high level may be derived from natural organic pollutants occurrences and/or human interference in BFR. The high BOD levels indicate high levels of organic pollutants and high ammoniacal nitrogen levels could be from runoffs of fertilizer and/ or organic decomposition by-product (refer to Section 6.3 on further discussion of sources). The water from W19F flows into AFI dam (W16Fa) located in Kg Bongkol with results showing improved water quality in BOD and NH3-N but slightly low in DO (4.74 mg/l). The decreased level of DO may be due to natural occurrences of aquatic plants that absorb DO and/or the presence of organic pollution or lack of re-aeration. As stream from Safoda dam in BFR to AFI dam in Kg. Bongkol passes through land covered with various vegetation and in the vicinity of Kg. Bongkol, the possibility of organic litter can come from both natural occurrence and/or human influence.

Water quality at W16F was found to be very polluted with levels of DO (3.35 mg/l), pH (5.38), BOD 12 mg/l), and COD (46 mg/l) found below or over permitted threshold. Site observations suggest that any residue collected in W16F stays undiluted during the dry season and therefore influencing its water quality. As W15Fa is located adjacent to the roadway, runoffs and CO2 may cause weak acid when dissolved in water. The low DO combined with high BOD and COD suggest pollution through organic waste matter decomposition. Especially during dry season, the organic waste matter will accumulate and without enough flow to move the waste, decomposition will occur in an almost stagnant water and hence results in low DO and high BOD and COD.

Water from W15Fa then flows to W17Fa located adjacent to an oil palm plantation at TANJ 03. The stream line from W15Fa to W17Fa goes through the vicinity of community farms, Acacia regeneration forest and secondary forest and therefore risk factors that came from organic litter and human interference may influence the DO and BOD levels. However, water quality at W17Fa showed that dilution/ aeration has increased DO level to 8.21 mg/l while BOD remains at 5 mg/l and pH found to have dropped to 5.07. The improvement of DO may be due to dilution/ aeration in the ±600 m length of travel which shows that the BOD level is maintained even though W17Fa is located adjacent to an oil palm plantation. pH level in the other hand may be influenced by pesticides/ fertilizer runoffs that can create a weak acid when dissolved in water.

There were no detectable levels of pesticides found in the samples of the observed streams of Sg. Bongkol.

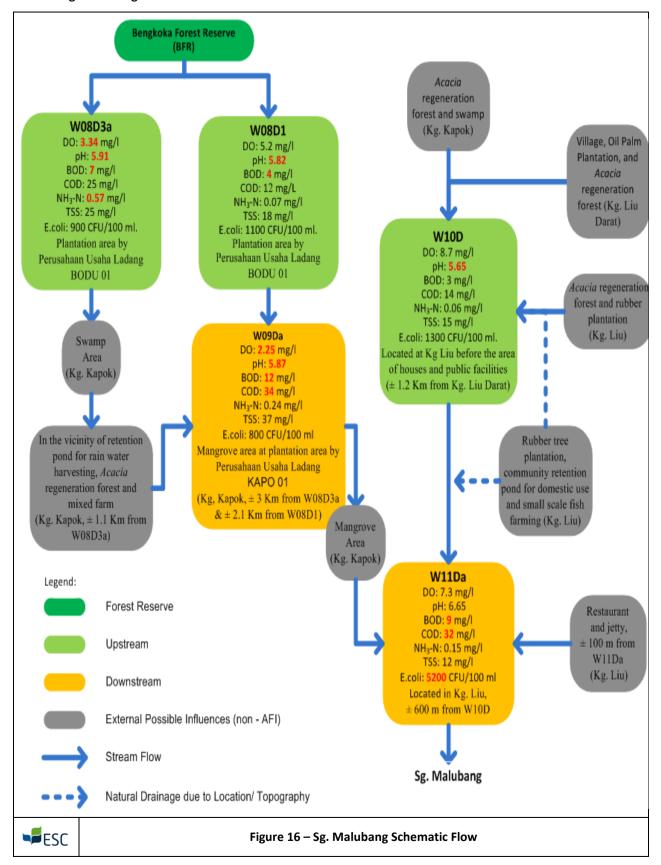
6.2.2 Sg. Malubang Schematic Flow

The upstream sampling locations for Sg Malubang were observed in 2 locations in Bodu (Perusahaan Usaha Ladang, BODU 01) and 1 location in Kg. Liu. The upstream locations in Kg. Bodu were located at the stream that came only from BFR (W08D3a) and a stream that came from BFR, Kg. Kandang and Kg. Kodong (W08D1). Meanwhile upstream in Kg. Liu was located at the stream (W10D) that originates from Kg. Liu Darat.

Water from BFR (W08D3a) was found classified based on WQI as very polluted. The BOD and ammoniacal nitrogen levels are similar to the other sample taken in BFR, (i.e W19F) but with the addition of low DO and pH levels. Because it was observed in adjacent to BFR therefore, it may be derived from natural organic pollutants occurrences and human activities in BFR. Sampling analysis showed that the stream has low DO (3.34 mg/l), high in BOD (7 mg/l) and NH3-N (0.57 mg/l), and pH slightly below threshold (5.91 mg/l). This water flows to the swamp area in Kg. Kapok then through an Acacia regeneration forest as well as a community mixed farm. A retention pond was also observed to be present in the vicinity of this stream.

W10D flows from Kg. Liu Darat and observed to have only slightly low pH (5.65). Oil palm plantation in Kg. Liu Darat may not be a direct influence to the BOD level at W10D as it is located ±1.2 Km away. Physical characteristics of the stream at W10D, i.e much wider width than other streams in BODU may be a factor that increases the dilution/ aeration rate which improved the water quality from W09Da which was classified as very polluted to slightly polluted at W11Da before it discharged into Sg. Malubang. High BOD (9 mg/l) and COD (32 mg/l) at W11Da was observed along with high presence of E. coli (5200 CFU/100 ml) that may come from the exposure to biodegradable organic matter, liquid manure and other liquid organic waste products to the waterbody in the surrounding populated areas (Kg. Liu Tamu).

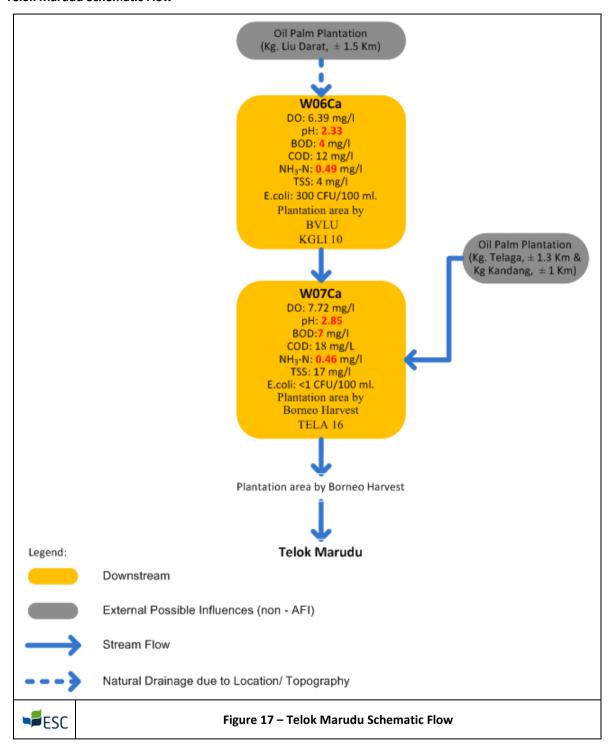
6.2.3 Telok Marudu Schematic Flow

There were no feasible upstream location in Telok Marudu river system to observe the water quality for the BVLU operated area in Kg. Liu as the location was not accessible due to natural conditions. Therefore, the original AFI own sampling points namely S8 and S10 were established as W06Ca and W07Ca respectively to observe the Telok Marudu river system.

W06Ca located at plantation area operated by BVLU was classified based on WQI as very polluted with the pH acidic (2.33) with slightly high BOD (4 mg/l) and NH3-N (0.49 mg/l). Organic litter from and runoffs from

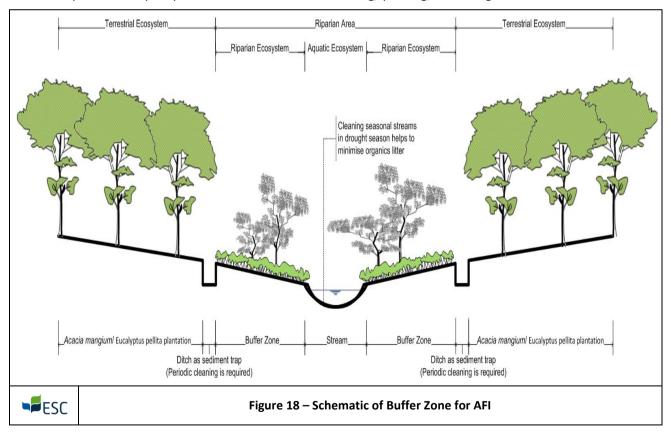
The width of the waterway between the banks	Reserve width
> 40 m	50 m
20 - 40 m	40 m
10 – 20 m	20 m
5 – 10 m	10 m
< 5 m	5 m

Reserve width as buffer zones which should also act as a floodplain as necessary are currently only located at non-seasonal stream. Therefore, it is recommended that buffer zones are also to be located at seasonal streams. Further recommendations include constructing a ditch between the plantation and buffer zone as sediment traps that is not connected to any waterbody that may flow into the surrounding river systems. To ensure the effectiveness, length of sediment trap should be at least twice the width of the ditch with bank side slope of 2 horizontal to 1 vertical or flatter to ensure its stability; sediments or muddy water should not be released to downstream; riparian vegetation along the banks of the watercourse should always be preserved; mud and oily sheen removal always be conducted whenever trench is half full; and screen to ensure the organics not passing the sediment trap is placed properly. Periodic cleaning of the ditch is required to ensure it functions efficiently. However, cleaning off organic litter at seasonal streams in dry season is also suggested as the first effort to reduce influential elements that can affect water quality in the adjacent streams. Ditch as sediment traps will then be applied when periodic stream cleaning is found inefficient to improve water quality and while the area is under clearing/ planting/ harvesting activities.
